# REPORT ON SAFETY AUDIT OF PUNE SATARA ROAD BETWEEN SWARGATE AND KATRAJ JUNCTIONS

ADDITIONAL CITY ENGINEER (BP & DP)  
PUNE MUNICIPAL CORPORATION

Creations Engineers Pvt. Ltd. and Pavetech Consulting  
Engineering Services Pvt. Ltd.

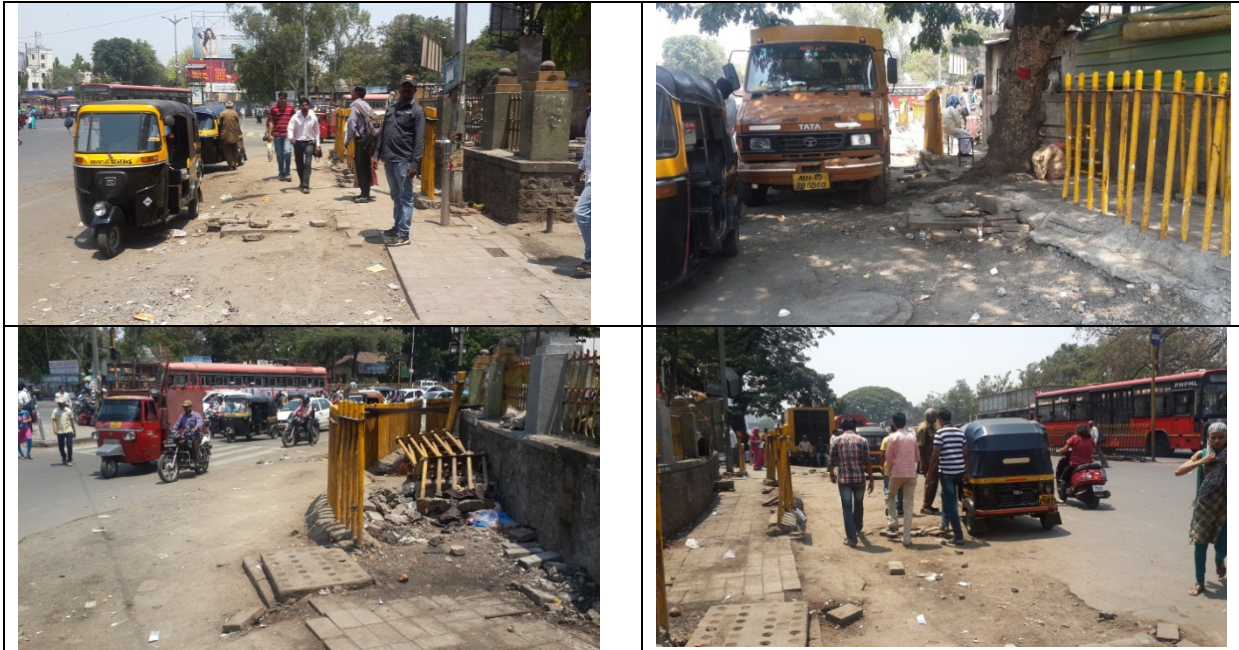
Swargate Junction outside ST depot (Chainage 5/975 RHS side Coordinates 18.500303, 73.858554) -The present condition of footpath with broken tiles, damaged railing, damaged kerbs, dislodged chamber covers, cables, debris and dirt dumped on the footpath makes it completely inaccessible to pedestrians who are forced to walk on the carriageway in the traffic flow thus occupying space for vehicles and endangering their own safety. Improvement in the above marked conditions of footpath and user utilities is necessitated on an urgent basis. This location is the convergence point for all modes of transport exiting Pune on the South, West and East side and therefore optimum use of available carriageway widths is necessary.

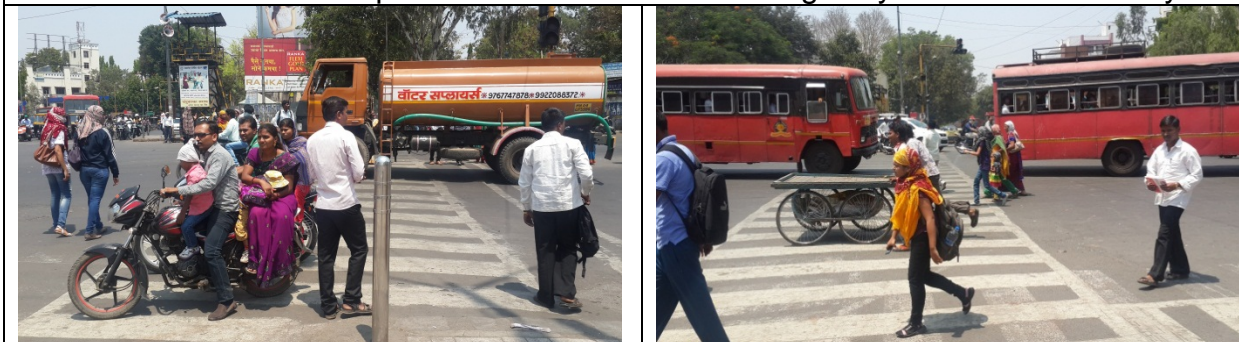
Swargate Junction outside ST depot (Chainage 6/000 RHS side coordinates 18.500568, 73.858476):Mixed traffic conditions with trucks, buses, two wheelers, NMT and public disregard to follow traffic rules creates difficult crossing situation for pedestrians. The pedestrian count being very high at this junction, improved and safe pedestrian movement facilities have to be encouraged. Segregation of heavy and other vehicles may also be implemented if the carriageway widths permit and will have to be resolved with a holistic approach.

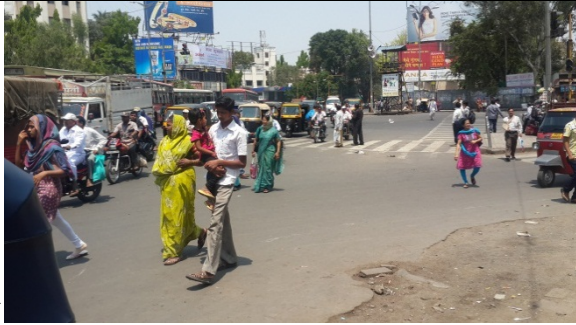
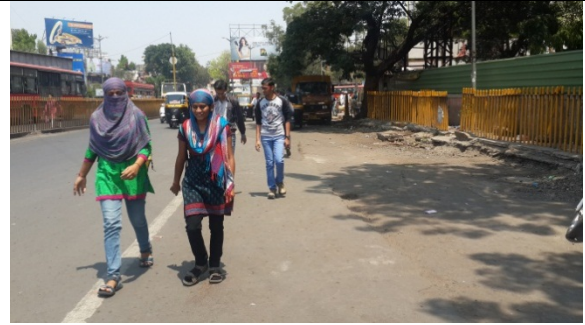
Swargate Junction outside ST depot (Chainage 5/950 RHS side Coordinates 18.500568, 73.858476): Pedestrians using the main carriageway have to walk near Swargate junction as the footpath space is inaccessible and hence not in use. Concurrently, space occupied by pedestrians creates traffic congestion at the junction and also endangers pedestrian safety.

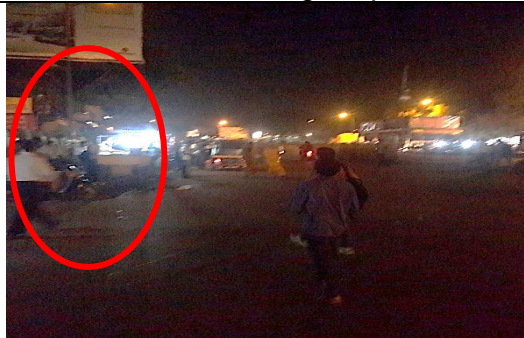
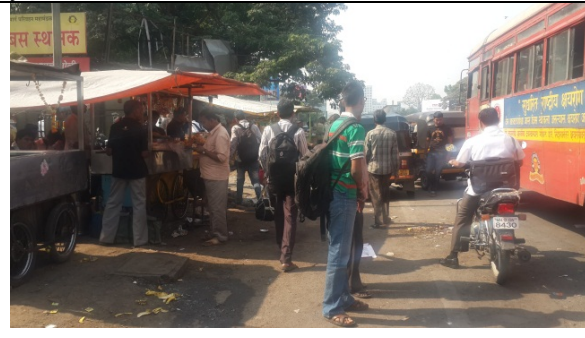
Swargate Junction outside ST depot (Chainage 6/000 RHS side Coordinates 18.500568, 73.858476): Space occupied by street hawkers during the day and night time creates difficult walking conditions for pedestrians and thereby restricting the width of vehicular space of the main carriageway.

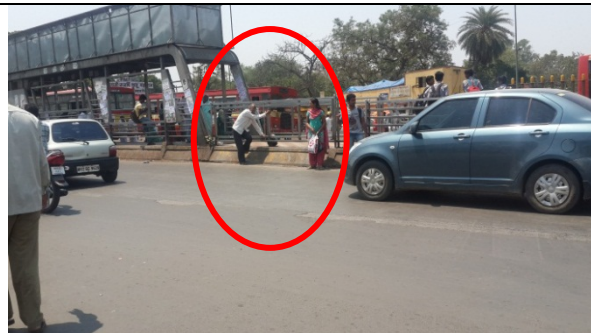
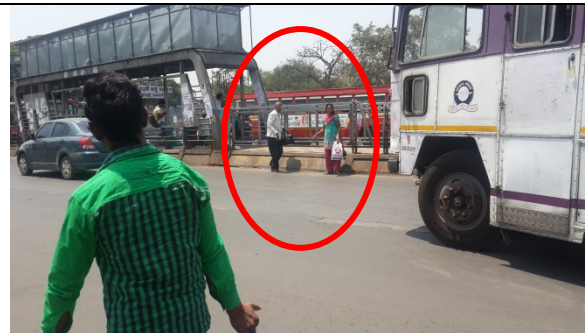
Outside Swargate ST Bus Depot (Chainage 5/900 RHS side Coordinates 18.500090, 73.858390) Inadequately marked pedestrian crossings at the BRTS bus stop near Swargate junction forces the BRTS users to take the shortest available route to cross the road through oncoming traffic thus endangering their safety. It is also observed that the buses try to use the bus stop space on each side of bus stop on either side. There is an urgent necessity to construct raised pedestrian / demarcated crossings all along the BRTS corridor.

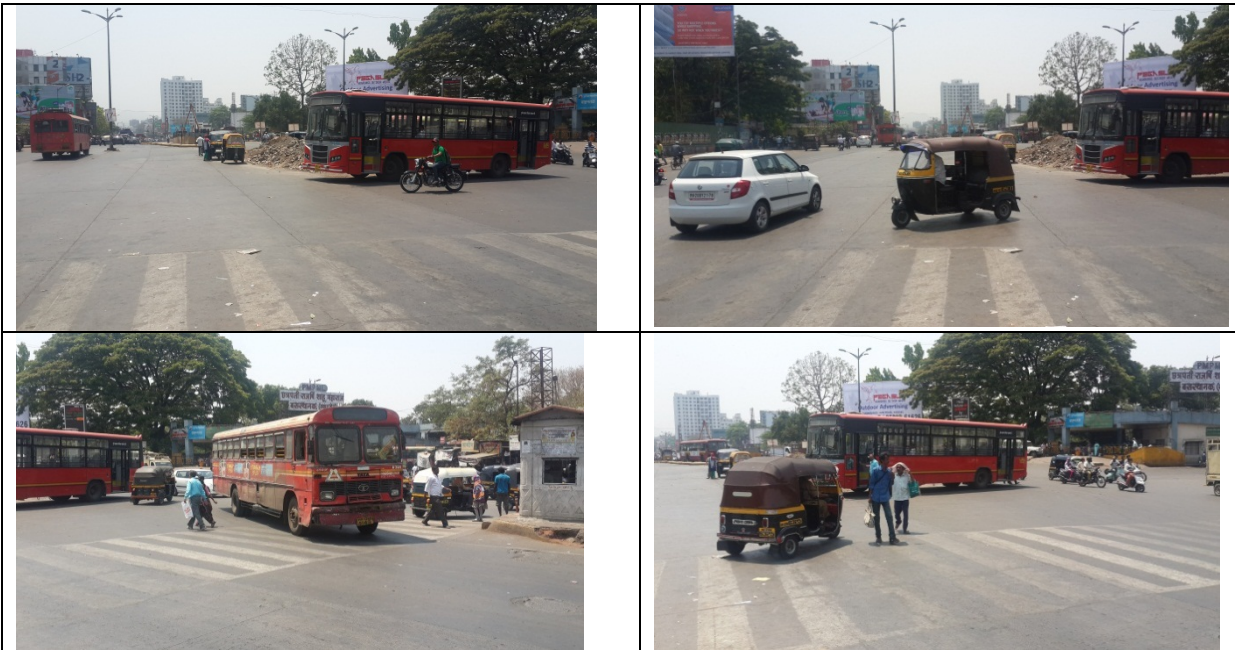
In front of new PMT Bus depot at Swargate (Ch 5/800 Coordinates 18.500090, 73.858390): The widened carriageway in front of Swargate ST depot is uncontrolled due to the absence of traffic island, channellizers etc. S.T. buses exiting the S.T. terminus conflict with the mixed traffic coming from Shankar Sheth Road, Tilak Road and Shivaji Road thereby leading to a queuing at the Swargate junction. Also, hawkers and auto rickshaws parked abutting the terminus compound wall make it difficult for the exiting buses to manoeuvre and therefore a complete ban on hawkers and channelization of auto rickshaws is imperative.

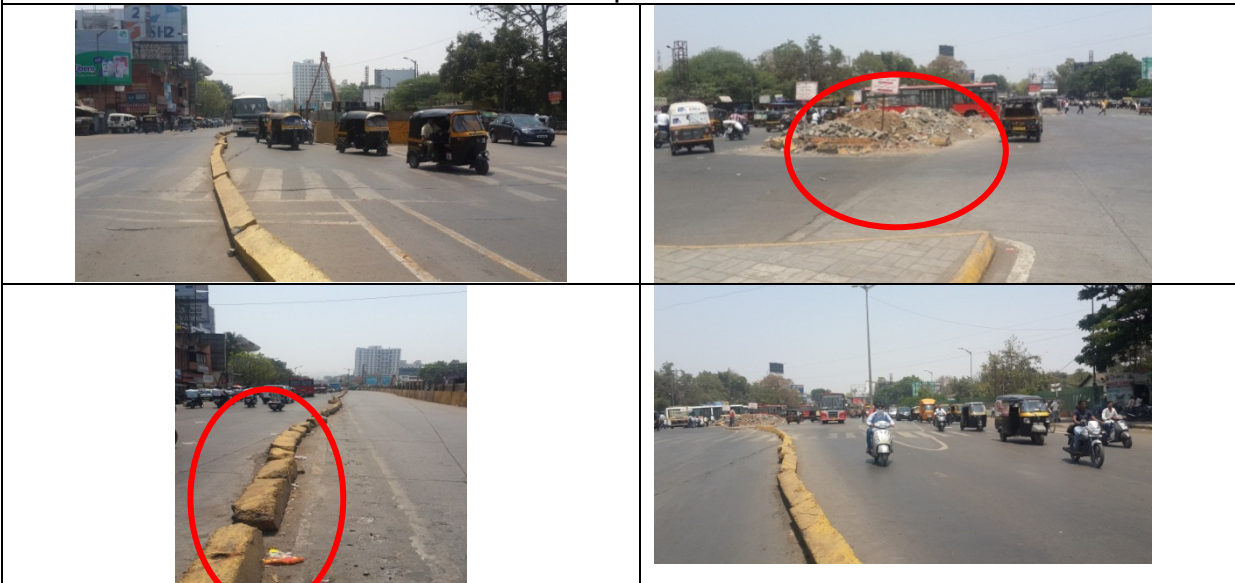
Chainage 5/750 Coordinates 18.498411, 73.858194: Construction debris due to removal of traffic island and haphazardly arranged concrete blocks for BRTS delineation creates hazardous driving conditions. Replacement of these loose blocks with new jersey type concrete barriers (removable type RCC barriers) until completion of the flyover work is necessary.

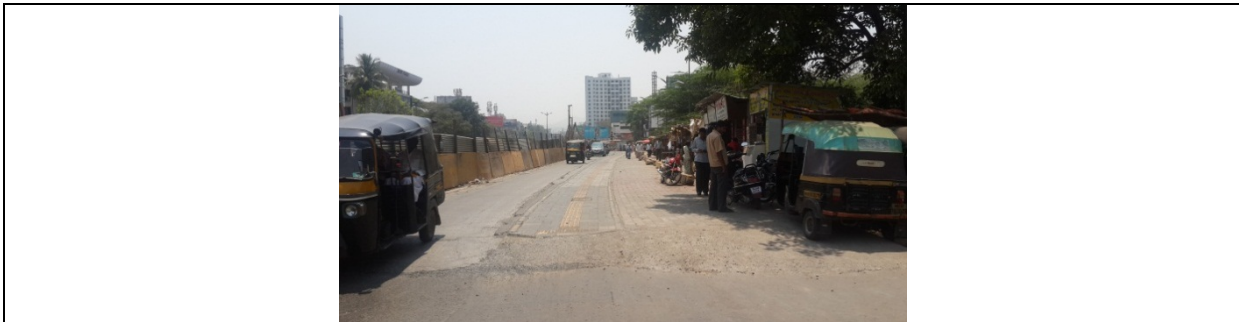
Chainage 5/700 LHS side Coordinates: 18.498411, 73.858194 - The present condition of the footpath, cycle track locations along the new Swargate flyover construction needs marked improvement. It is necessary to rebuild the carriageway by merging with the cycle track until the completion of the flyover. This work also needs the rebuilding of raised and clearly separated footpath with safety railing. The footpath space is occupied by vendors and these need to be shifted/removed.

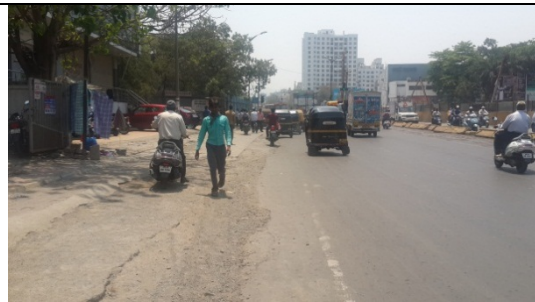
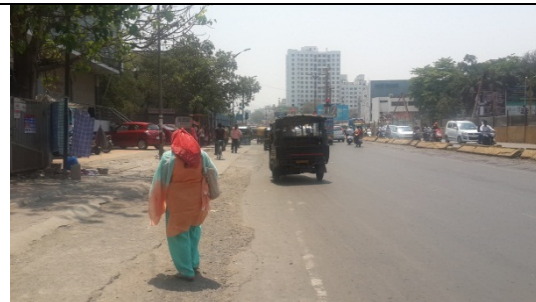
Chainage 5/650 RHS side Coord18.498411, 73.858194: Concrete ramp at joint between the main carriageway and cycle track in between Swargate and Laxminarayan junction is in poor condition; makes driving difficult: also gives unnecessary access to the vehicles to the cycle track and pedestrian area

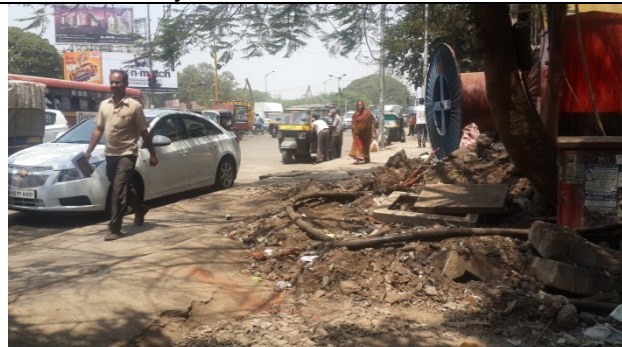
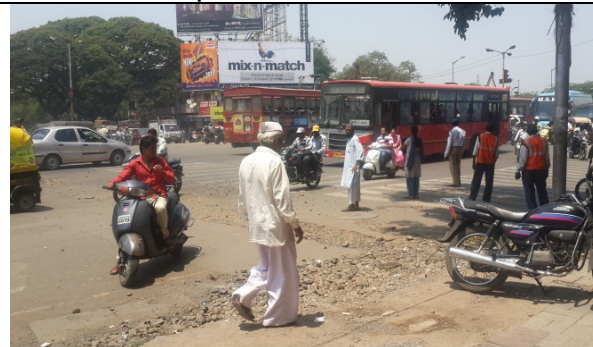
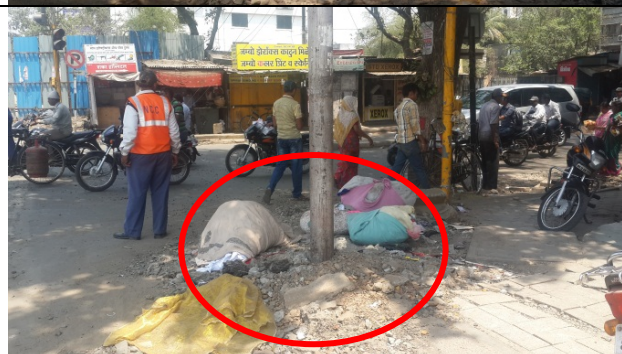
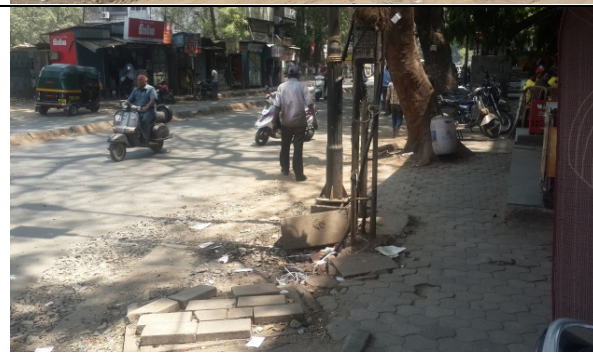
Laxminarayan junction on Mukund Nagar side (Chainage 5/550 RHS side Coordinates 18.498411, 73.858194)– Improvement in pedestrian accesses at this junction is urgently required. Pedestrian movement is restricted due to construction and other debris, vendors, hawkers and also blocked by street light poles, signal poles, traffic signage poles and electrical / phone boxes. This situation is more or less common to all the major junctions.

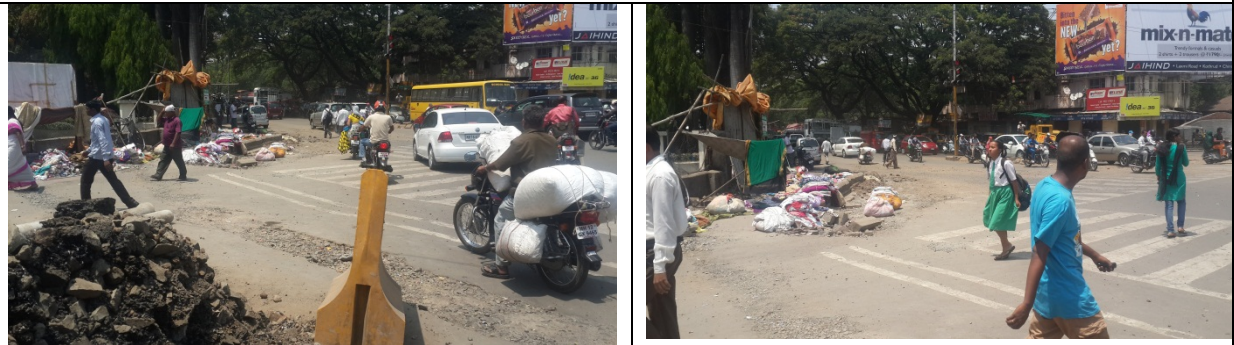
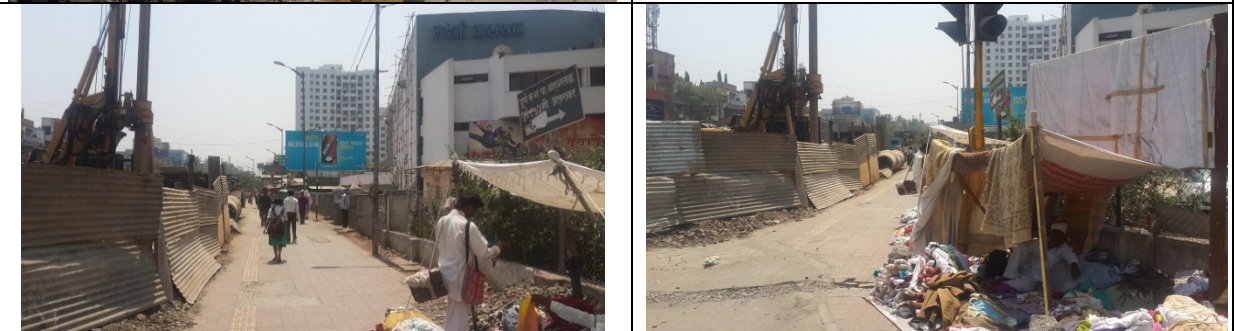
Laxminarayan junction on Mitra Mandal side (Chainage 5/550 LHS side) - Tin sheet barricading needs to be replaced with safe well fabricated MS barricading. Some tin sheets are opened and loose which pose danger to vehicles. The pedestrian accesses are blocked by hutments on the footpath. The cross cuts and digging due to service utilities need to be urgently tackled.

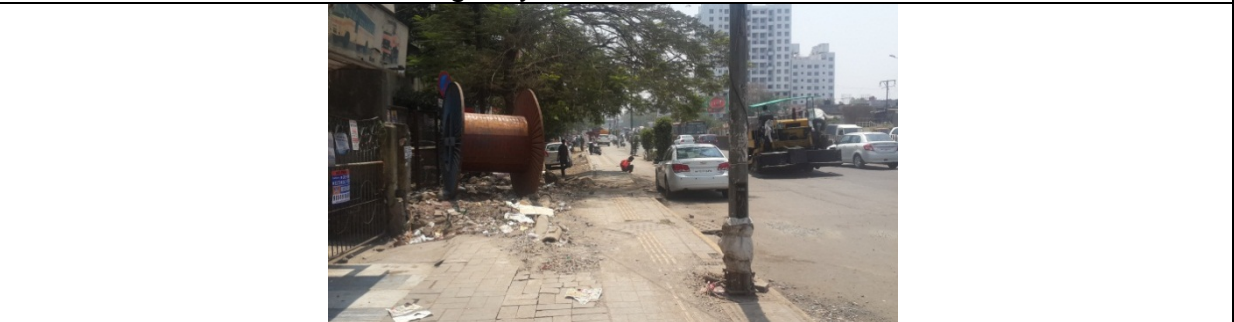
Footpath and cycle track after the Laxminarayan junction (Chainage 5/525 RHS side Coordinates 18.498411, 73.858194) – The cable bobbin of the MSEDCL and excavation debris is dumped on the footpath thus blocking the access to pedestrians.

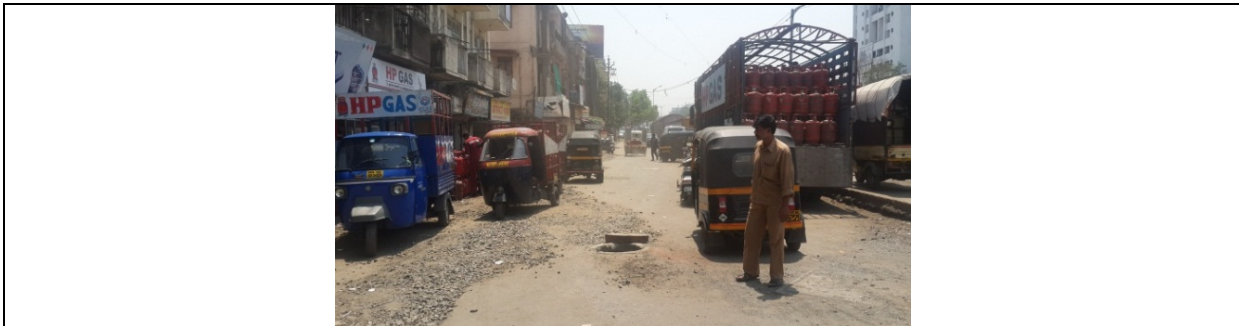
Service road in front of Saibaba Mandir (Chainage 5/350 RHS side 18.498411, 73.858194) is deteriorated and haphazard parking and use for commercial activities like loading and unloading during daytime creates unusable conditions for local traffic.

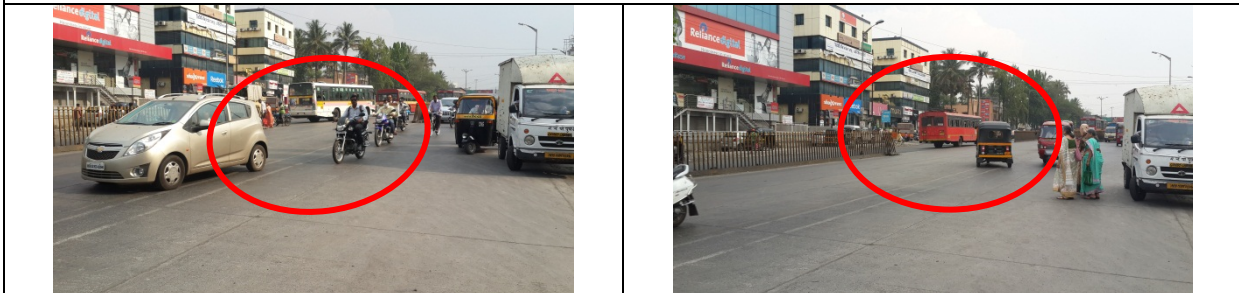
Location in front of Reliance Digital mart (Coordinates 18.494532, 73.858073) – The break in the BRTS corridor due to ongoing construction has created an unsafe merging location for fast moving buses from central BRTS corridor to merge with the vehicles on the main carriageway. Other vehicles also cross the BRTS corridor at this location leading to a high accident potential at this location. It is recommended that traffic calming measures shall be provided at the end of dedicated BRT corridor to reduce the speed of merging buses.

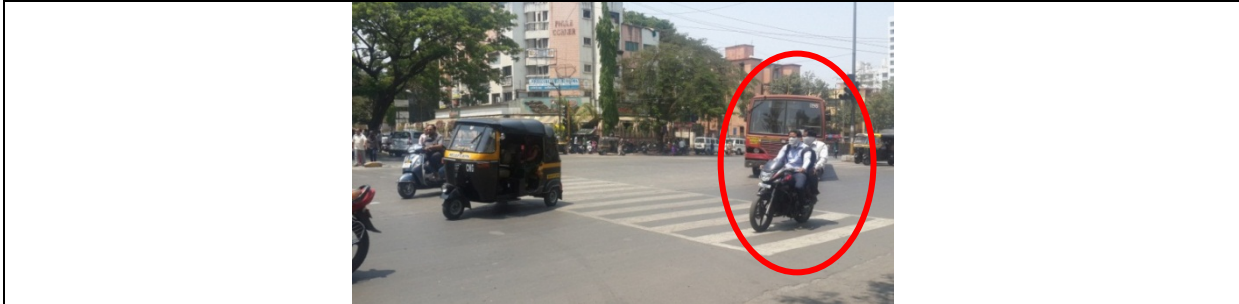
Panchami Hotel junction (Chainage 5/100 Coord- 18.498411, 73.858194) – The BRTS is discontinued after this junction and speeding buses from BRTS corridor merge into the main carriageway traffic posing danger to the oncoming vehicles in the main carriageway. There is no advanced warning sign to vehicles on main carriageway about the merging buses. Hence traffic calming measures are recommended.

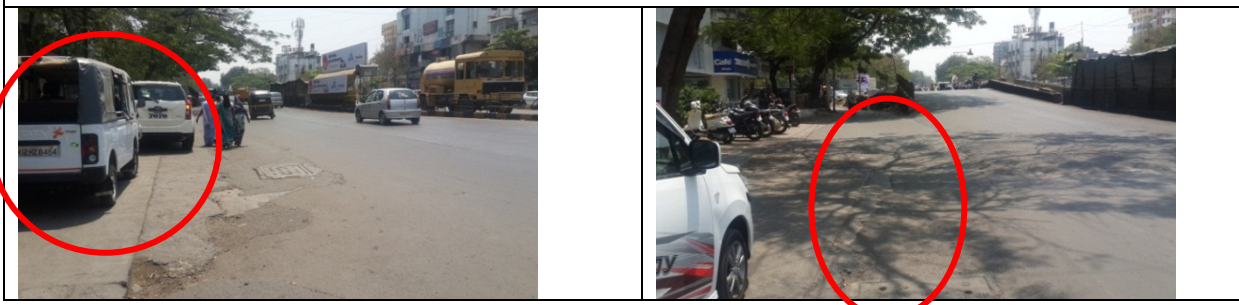
Cycle track and footpath occupied by parked vehicles between Panchami junction and Utsav Hotel junction (Chainage 4/850 RHS side 18.498411, 73.858194) forcing the pedestrians on to the main carriageway. Poor condition of concrete ramps at various property entrances is observed.

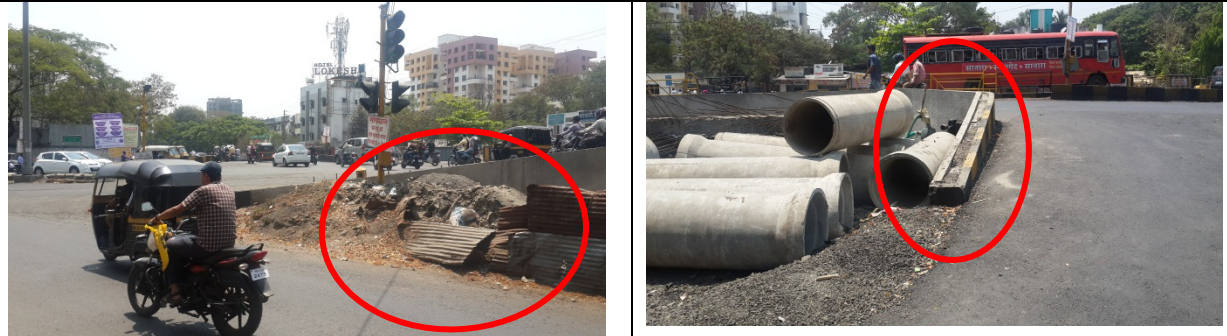
Pushpamangal junction (Chainage 4/500 RHS side 18.486996, 73.857535) – Excavation debris is littered at the edge of the ongoing subway and poor traffic barricading with thin tin sheets on the service road endangers vehicle and pedestrian safety. The height of the RCC crash barriers at the edge need to be raised suitably after completion of the bituminous works in the ramp portions. It is also recommended that the vehicles coming from Swargate side and going towards Bibwewadi side (left turn movement) from top of RCC box shall be banned and it is also recommended that this vehicle movement shall be restricted in the lane between footpath and end of RCC box.

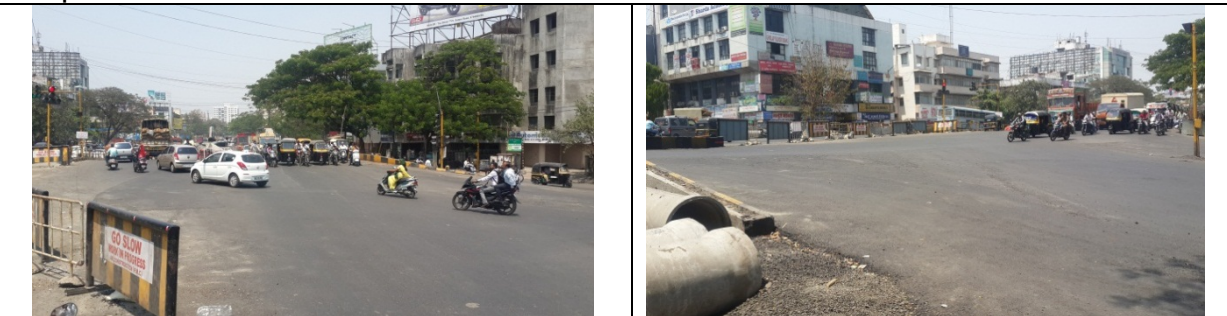
Pushpamangal junction (Chainage 4/500 Coordi 18.486996, 73.857535) – Resurfacing of the junction area has resulted in significant increase in the vehicular speed. Traffic calming measures like channellization, road marking, signages etc need to be undertaken before the completion of the project. The segregation of traffic from Satara road and Bibwewadi is required to avoid conflict of traffic from Bibwewadi crossing the traffic from Katraj moving towards Swargate. Fattening the junction and ramp slopes is already initiated despite probable problems with the adjacent accesses.

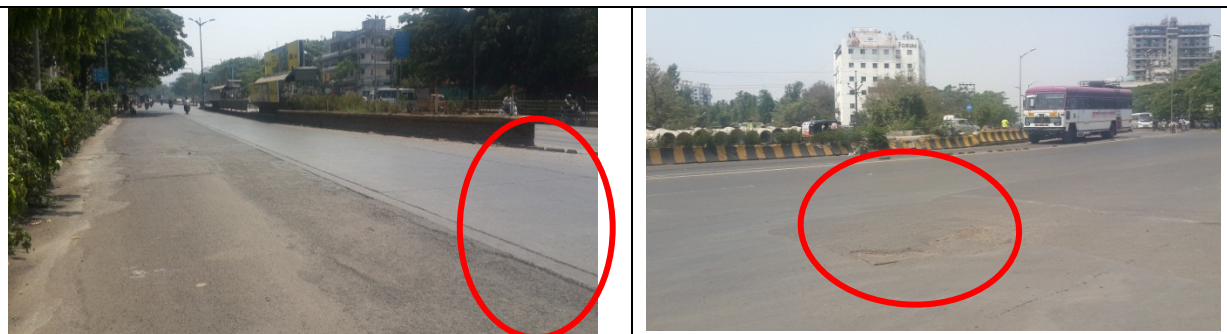
Section between Pushpamangal chowk and Padmavati junction (Chainage 4/300 Coordi 18.473105, 73.856618 & 3/700 RHS side) – The level difference of 30-40 mm

between the concrete pavement and the BT edge creates unsafe riding condition for two wheelers. The SWD chambers are in poor shape and settled chambers with damaged covers need to be repaired.

9. Activities like resurfacing with proper levels of damaged carriageway portions shall be undertaken immediately along with reinstatement of kerbs and medians. Excessive care to be taken when levelling at portions where there is a level difference between the BT and concrete corridors and also where longitudinal gaps are located **(Phase I)**.

10. Damaged, protruding and sagged storm water chambers shall be immediately repaired or raised / lowered to the level of the resurfaced corridor. Damaged chamber covers shall be replaced **(Phase I)**.

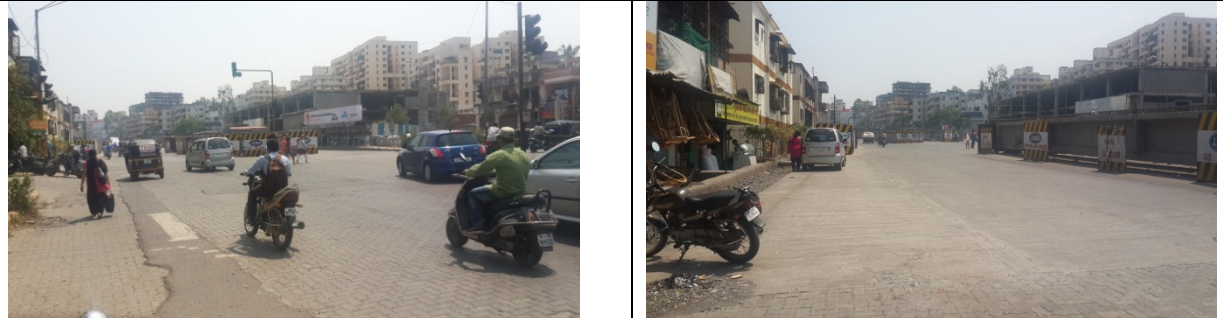
Dhankawadi Flyover construction zone (Chainage 3/200 RHS side 18.473105, 73.856618) – The construction zone lacks adequate advanced warning signs. The girder casting yard is located in the centre of carriageway and the carriageway has been widened upto end of the ROW. This has resulted in the elimination of footpaths inconveniencing pedestrians. It is recommended to provide segregated pedestrian passage by providing MS barricading.

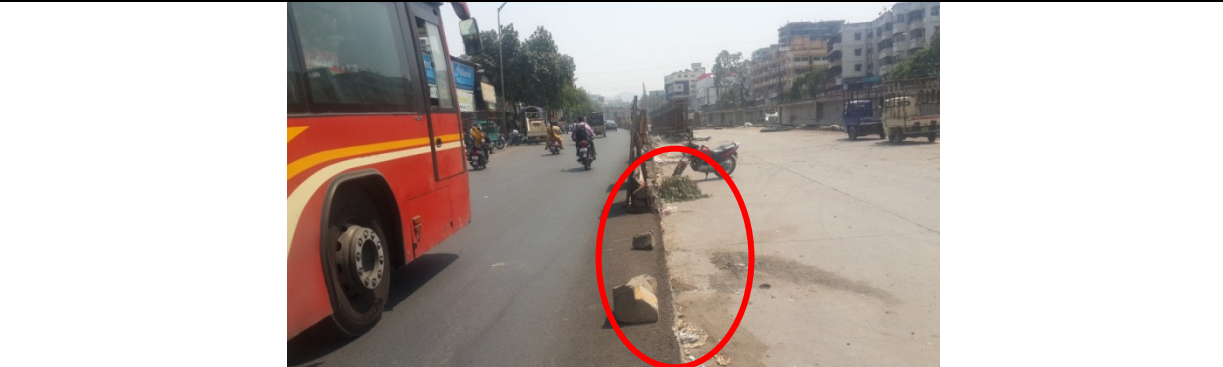
Chainage 3/150 RHS side -Level difference in existing carriageway and the construction zone is ill protected and needs continuous barricading.

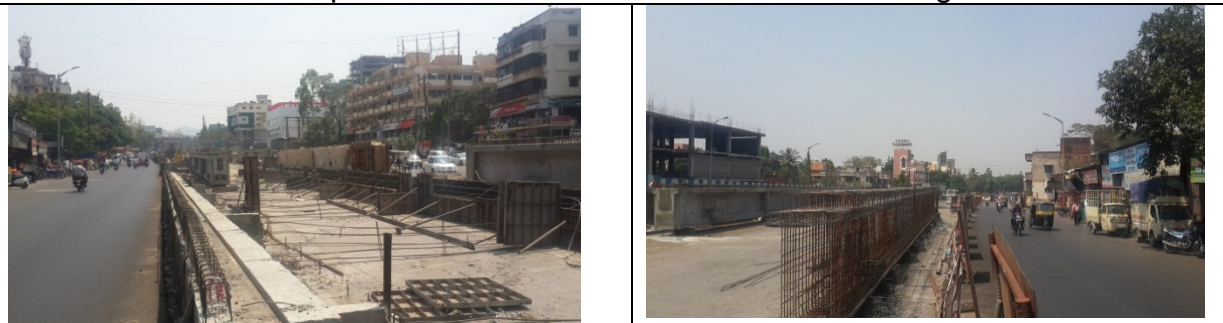
Construction zone Dhankawadi flyover (Chainage 3/050 RHS side 18.473105, 73.856618) – Exposed reinforcement of the RCC wall under construction needs to be barricaded.

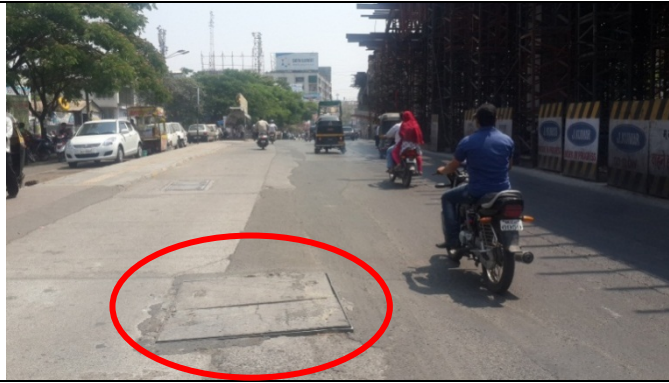
Near Balaji Nagar Junction (Chainage 2/ 550 m RHS side 18.468892, 73.857927) – Protruding frame and RCC chambers of utilities create obstructions in the main carriageway.

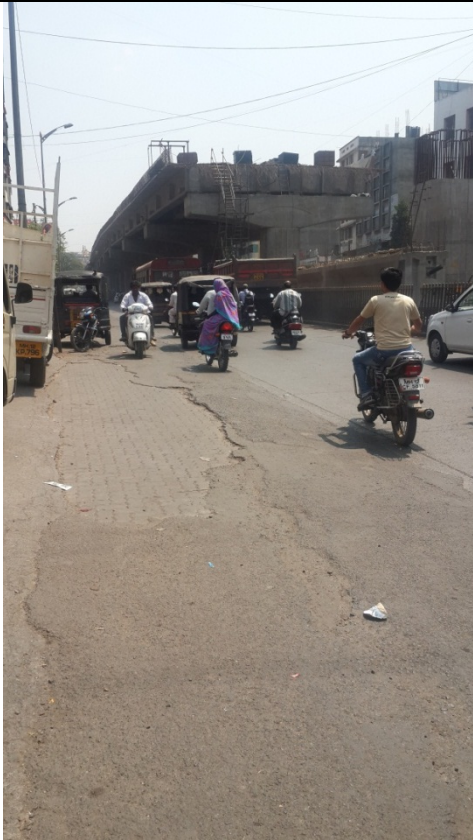
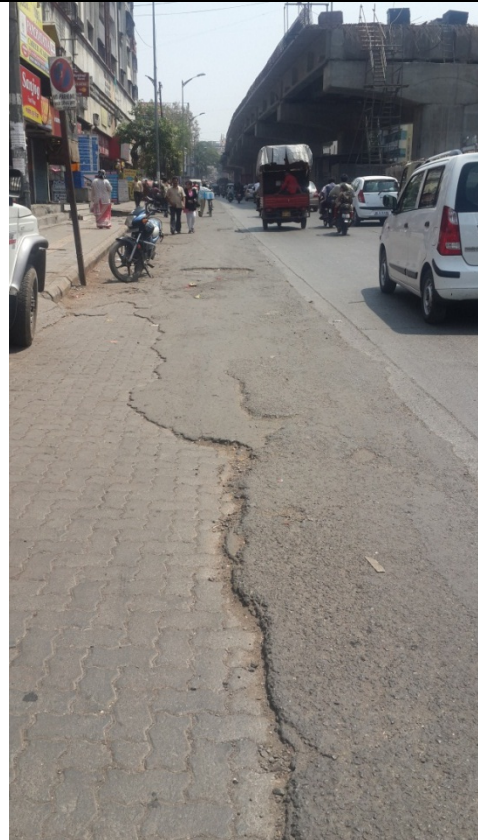
Construction zone Dhankawadi flyover (Chainage 2/350 RHS side 18.465086, 73.858158)– The edge strip of 3 to 3.5 m (one lane) is in a bad condition and needs to be replaced / repaired by eliminating the level difference which tends to lower the speeds of two wheelers and other vehicles and results in congestion. Parking in this area needs to be banned until the completion of flyover.

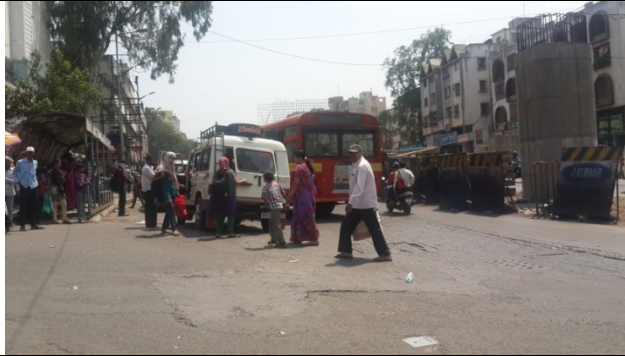
Petrol pump near Dhankawadi Bus route (Chainage 1/950 RHS side 18.464231, 73.858330) – The location of Bus stop and ongoing construction work has reduced the width of carriageway. The physical state of the carriageway needs urgent improvement.

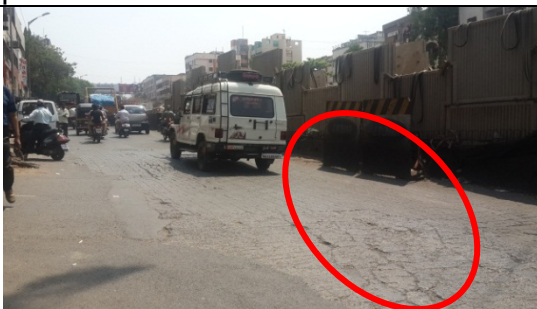
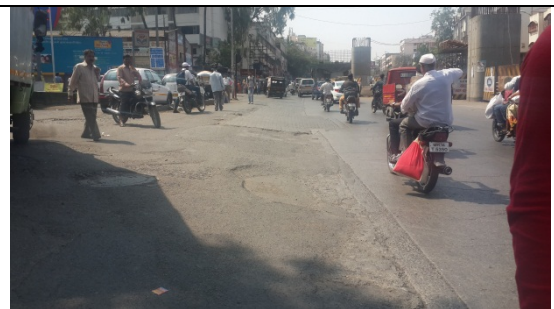
Chainage 1/900 RHS side 18.464231, 73.858330: Poorly maintained service roads along the ongoing construction project create hazardous driving conditions for all road users. The physical state of the carriageway needs urgent improvement.

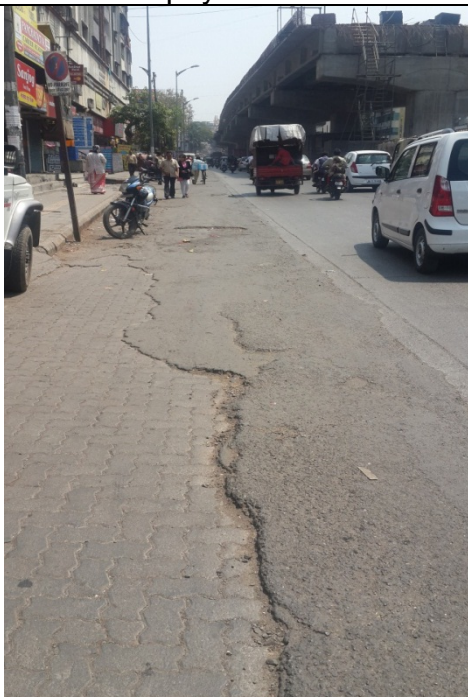
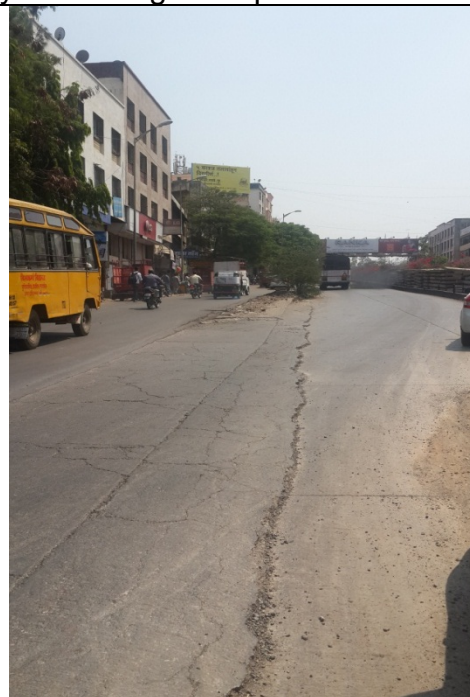
Chainage 1/750 RHS side 18.460663, 73.858184: Poor condition of the edge strip, concrete ramp joint has rendered the space unutilized along the construction zone of Dhankawadi flyover/

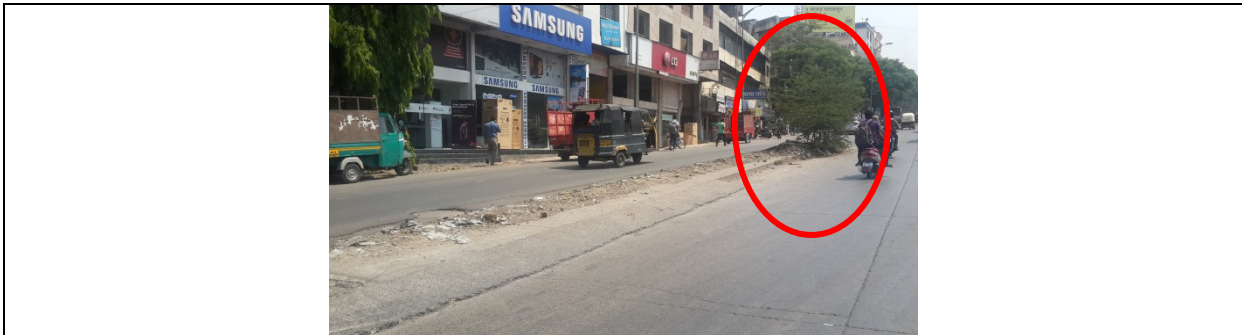
Chainage 1/650 RHS side 18.460663, 73.858184: A tree in between the main carriageway and service road obstructs vision and poses danger to oncoming traffic.

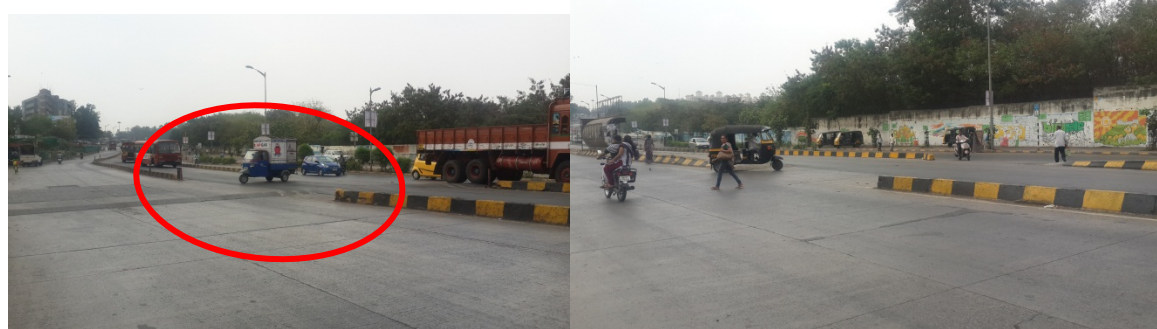
Chainage 0/400 m LHS side – Break in the BRTS corridor at minor cross road gives access to all other vehicles to cross the BRTS corridor creating unsafe driving condition for the BRTS buses as well as the other vehicles.

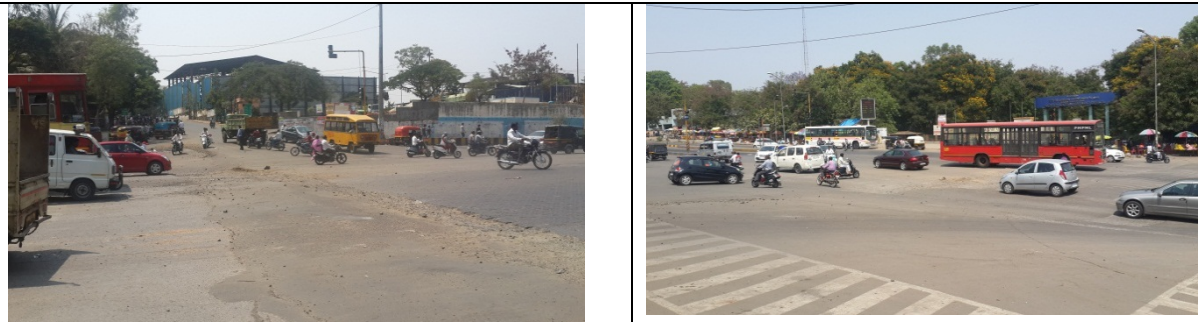
Katraj Zoo junction (Chainage 0/800 m 18.454435, 73.858613)– Cross cut taken by MNGL has left the main carriageway in poor condition and unattended. Driving conditions are extremely hazardous. There is lack of channelization at this wide junction creating chaotic situation. There is no provision for a pedestrian crossing in this stretch where the road is 60 m wide at the junction.

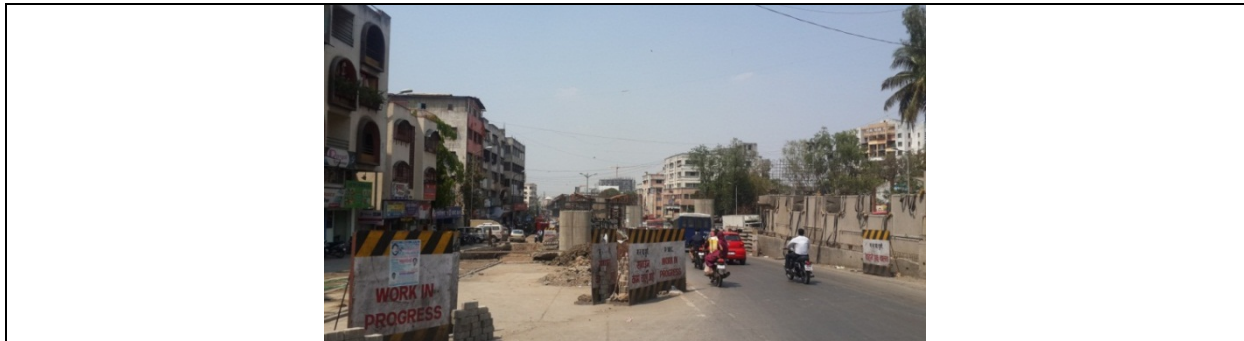
Chainage 1/600 LHS side 18.461844, 73.857798: Inadequate construction barricading for ongoing flyover should be improved. Advance warning signs need to be installed showing obstruction, reduction of carriageway width etc.

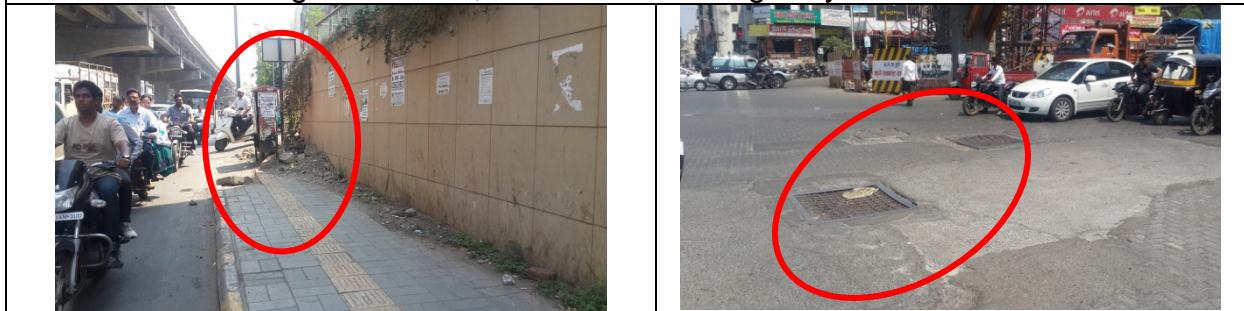
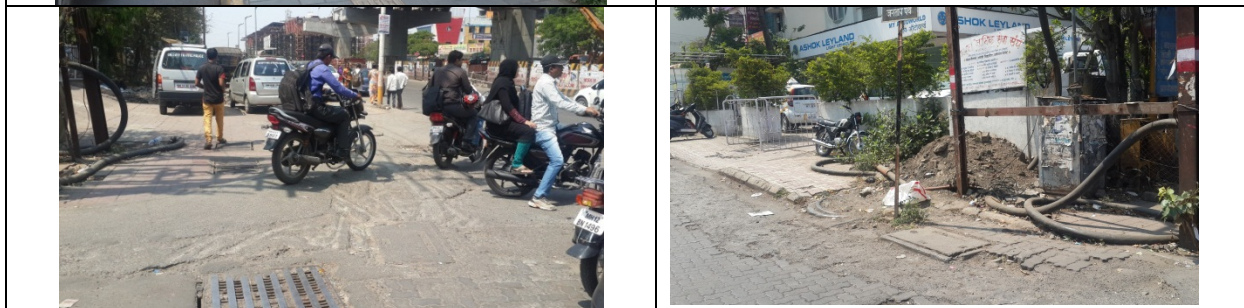
Balaji Nagar junction (Chainage 2/300 LHS side 18.468276, 73.857390) – Improvement at corners due to existing electrical poles, boxes, debris, cables, etc is necessary. Improvement is necessary to eliminate the level difference in the paved carriageway and settled SWD chambers on urgent basis.

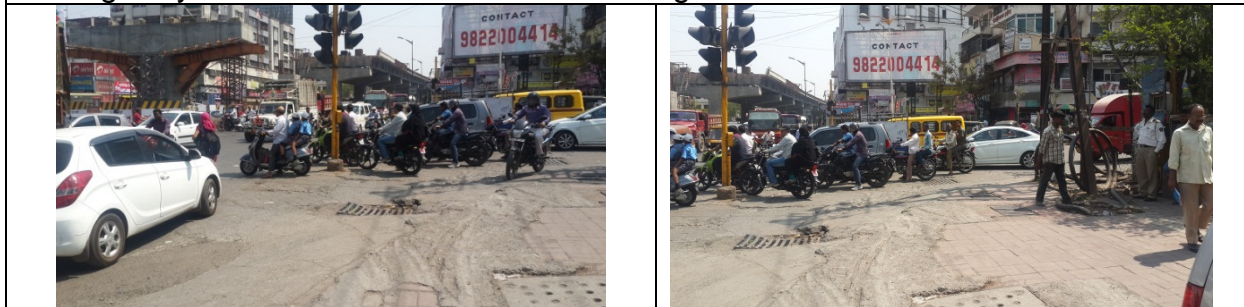
Chainage 2/325 LHS side 18.468276, 73.857390: All SWD chamber covers at this location need to be repaired/ replaced to match with the level of the resurfaced carriageway

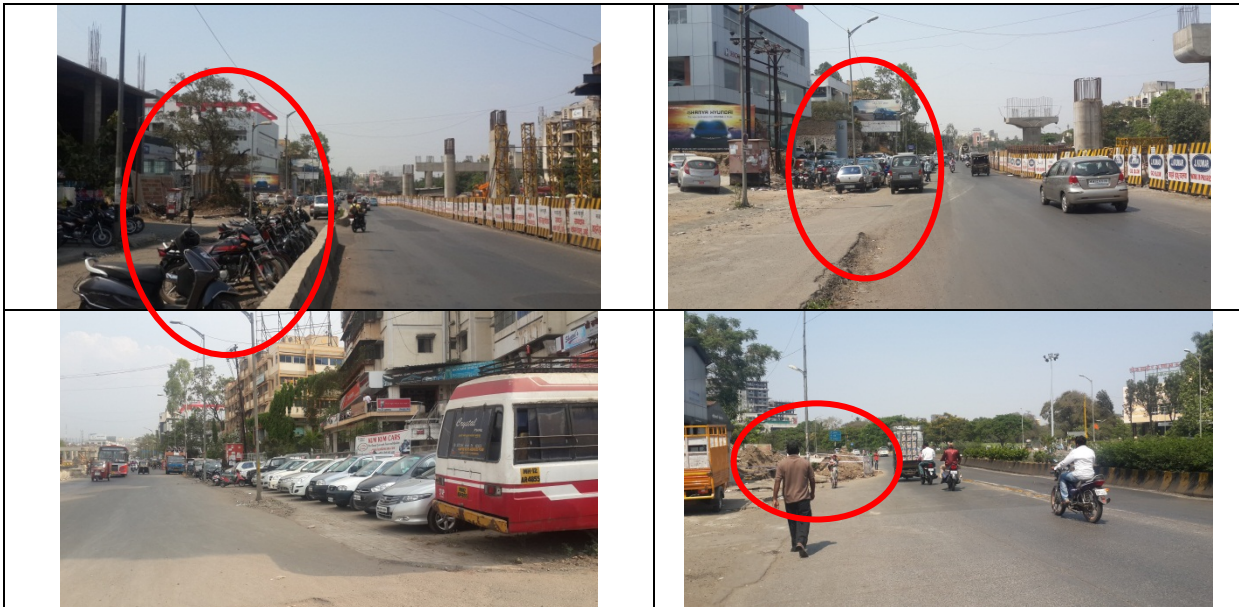
Chainage 2/600 LHS side 18.472073, 73.856421: Service road opposite Shankar Maharaj Math is completely occupied by parked vehicles (two wheelers and cars) by the dealers who own showrooms in this stretch (Deccan Honda, Vijay Motors, Mahindra two wheelers). Debris on the main carriageway should be removed and traffic signage, diversion board, etc need to be installed to warn the users about the obstructions on the road.

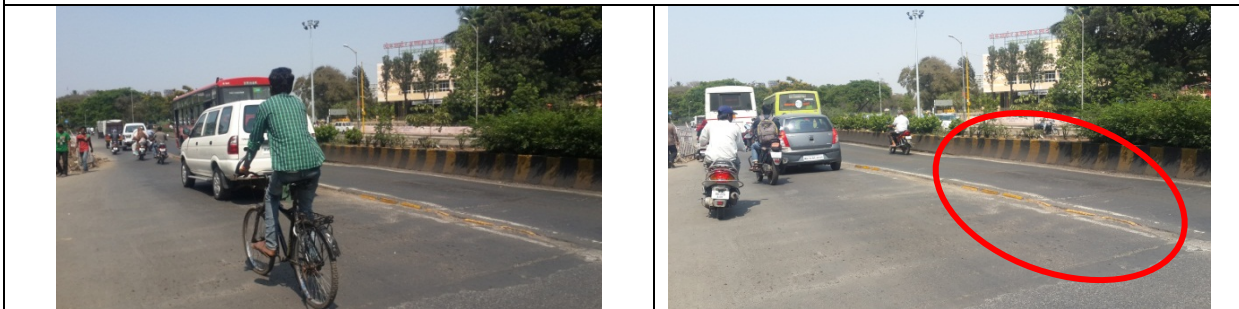
Chainage 3/250 LHS side 18.477792, 73.856893: Damaged separator blocks of BRTS corridor at Padmavati junction create unsafe condition for two wheelers and cars and need to be repaired.

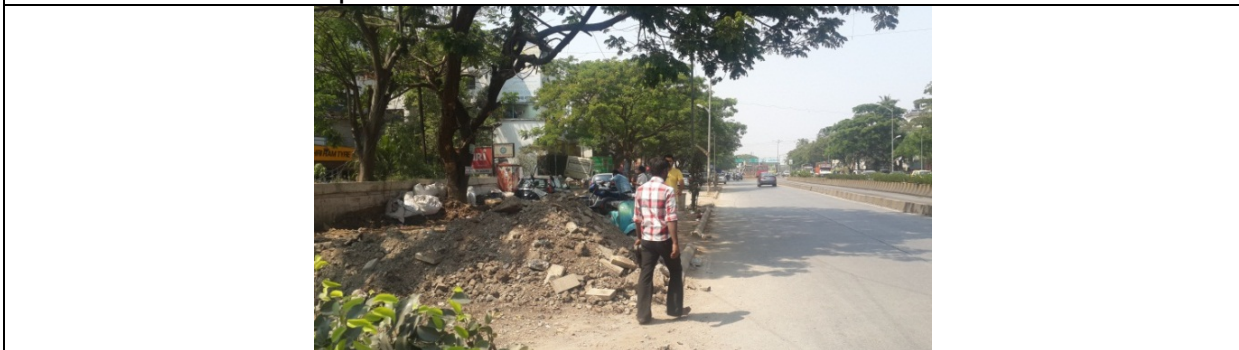
Chainage 3/450 LHS side 18.482106, 73.857022: The service road area, footpath and cycle track has been excavated by MNGL and no safety measures, traffic diversion arrangement, signage, etc. have been installed. General sensitivity of service providers towards user safety is found to be in vast disparity with PMC requirements. Pedestrian access is completely blocked and it is necessary that all utility providers should be refrained from commencing any work without installing

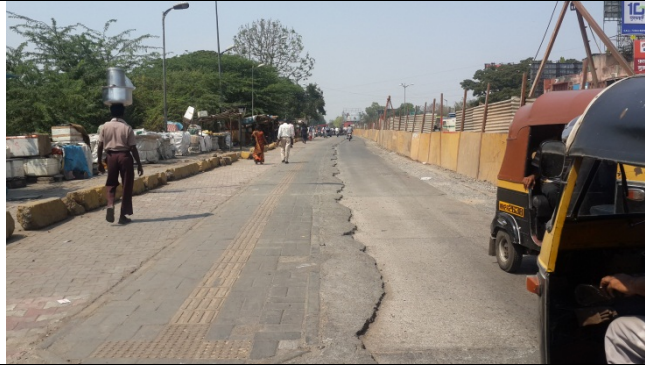
Chainage 5/600 LHS side 18.497409, 73.857880: Damaged concrete ramp edge with longitudinal level difference abutting the flyover construction area creating hazard to vehicles. The level difference needs to be rectified.

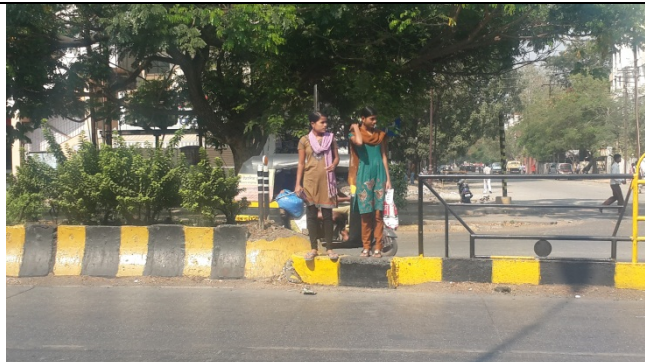
Location of Rao Hospital Chainage 4/050 RHS side 18.480152, 73.857429- Pedestrian crossings at various locations need to be demarcated by thermoplastic strips or raised pedestrian crossings in order to curb unsafe crossing by pedestrians.

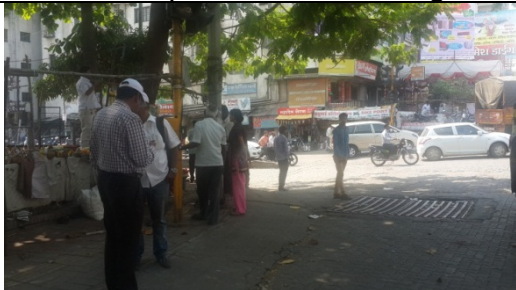
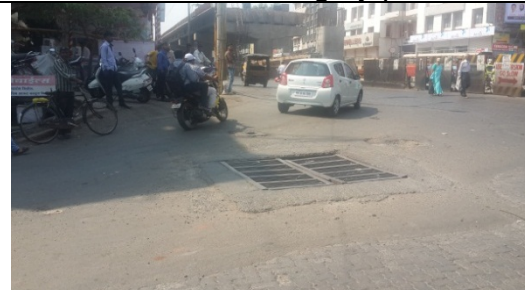
Chainage 2/400 RHS side 18.468409, 73.857880: Poor condition of footpath and deflected SWD chambers at the Balaji Nagar junction need urgent repairs / rehabilitation.

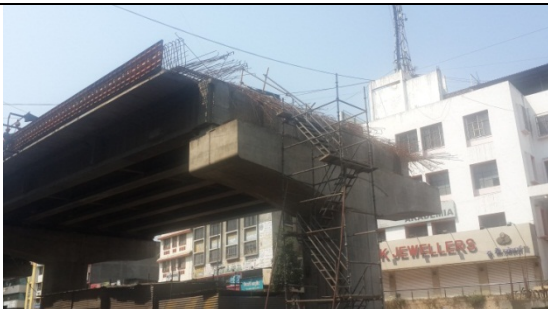
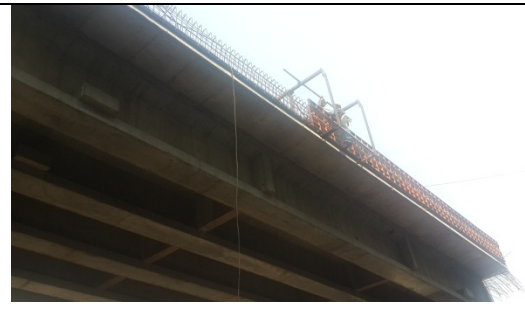
Chainage 2/250 RHS side 18.464379, 73.858245: Safety nets need to be provided on either side along the entire length of the flyover under construction for safety of traffic plying under the ongoing construction work as well as the workers on the

flyover project.
