# REPORT ON SAFETY AUDIT OF PUNE SATARA ROAD BETWEEN SWARGATE AND KATRAJ JUNCTIONS

ADDITIONAL CITY ENGINEER (BP & DP)  
PUNE MUNICIPAL CORPORATION

Creations Engineers Pvt. Ltd. and Pavetech Consulting  
Engineering Services Pvt. Ltd.

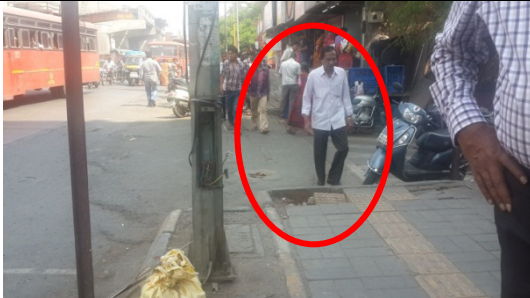
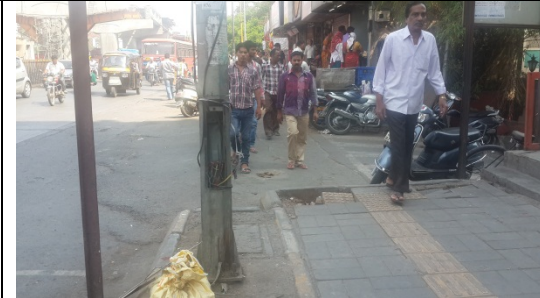
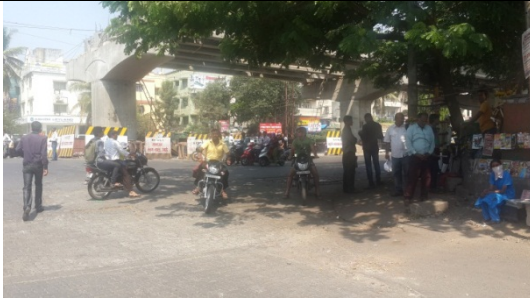
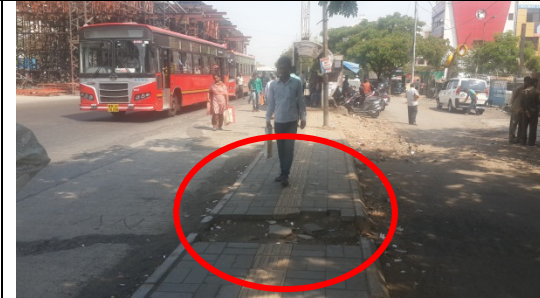
Chainage 2/200 RHS side 18.465987, 73.858159: Footpaths with missing / disjunct pavers need to be rectified as pedestrians avoid such stretches and flow over on to the main carriageway.

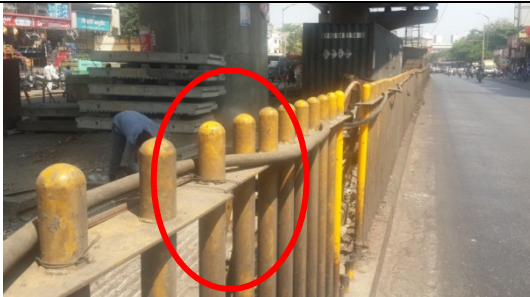
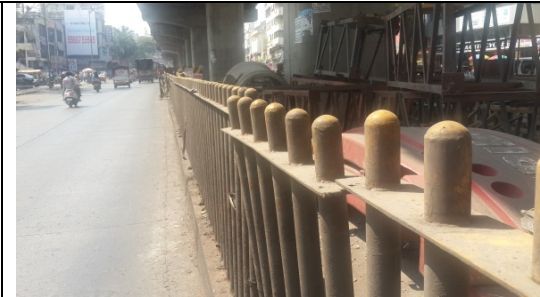
Chainage 2/100 RHS side 18.462303, 73.858245: MS flats used in the railing for BRTS corridor with open joints pose a grave threat to commuters, especially two wheelers and accidents can pose a grave risk and be fatal since they are at the head or neck level of the two wheeler riders or pillions.

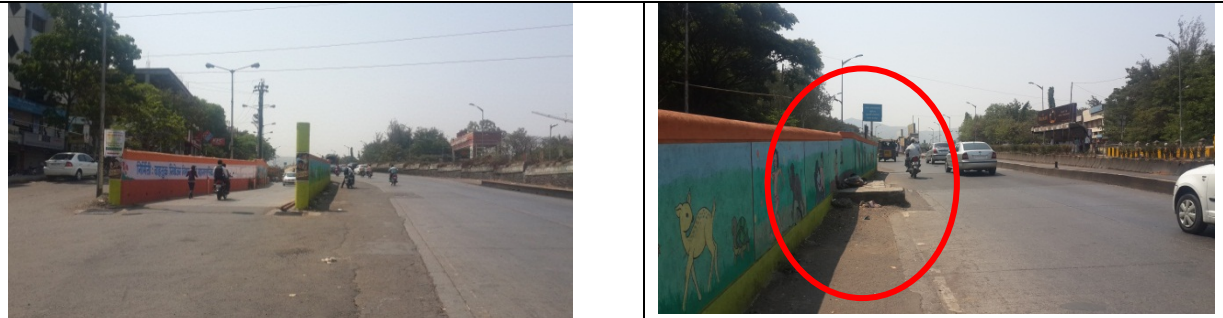
Chainage 1/350 RHS side 18.460145, 73.858138: The entrance to the vehicular subway leading to Bharati Vidyapeeth needs to be demarcated with advanced direction boards and delineated. Concrete block on the main carriageway abutting the subway wall needs to be urgently removed.

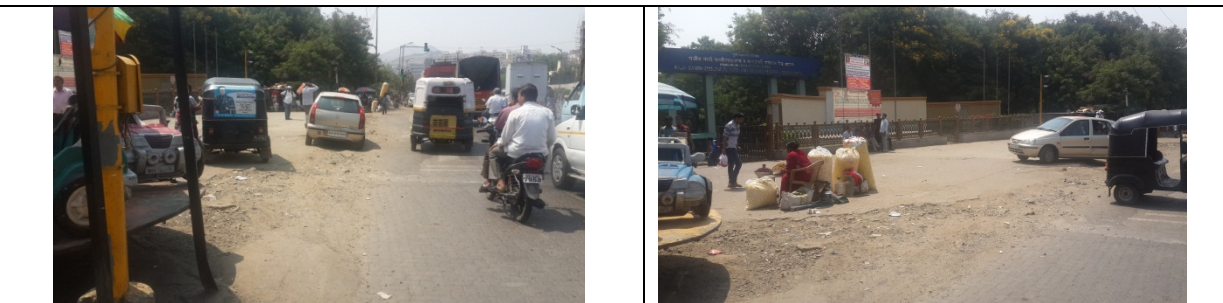
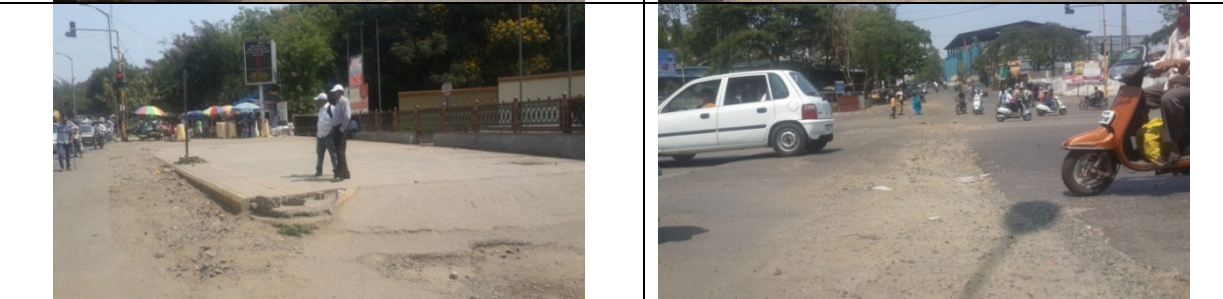
Chainage 0/800 m RHS side 18.454446, 73.858846: The entire stretch of footpath needs to be rectified near Katraj Zoo Junction in order to eliminate the level difference. The main carriageway needs resurfacing and matching of levels.

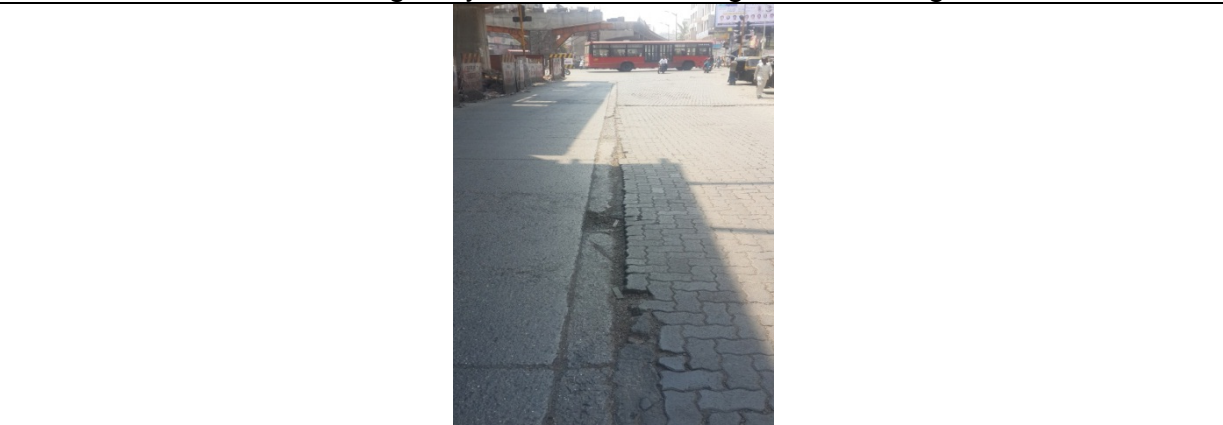
Chainage 2/450 LHS side 18.469223, 73.857194: Difference of 40 -50 mm in longitudinal direction (gaps) in the main carriageway leads to skidding of the two wheelers and needs to be rectified urgently.

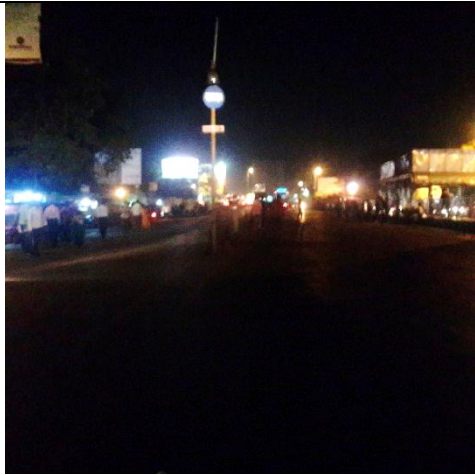
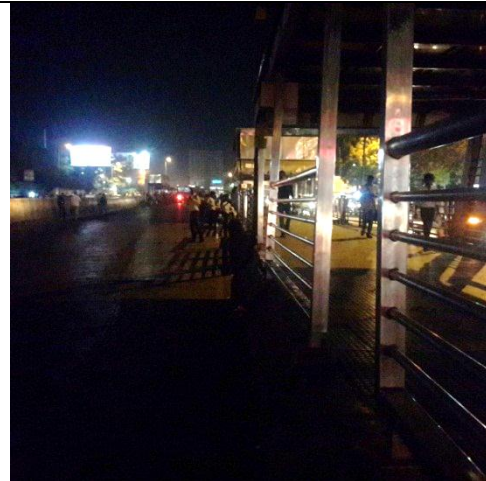
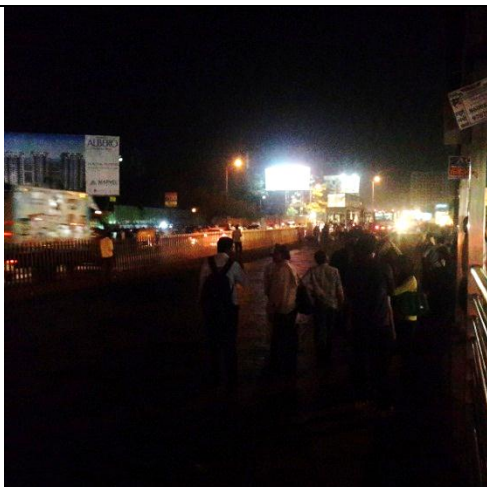
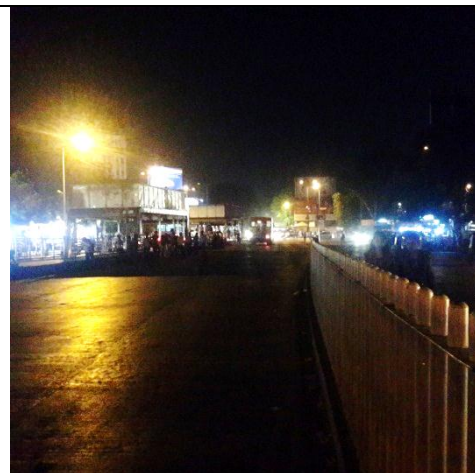
Chainage 5/850 m 18.500131, 73.858385: Lack of adequate illumination at Swargate junction BRTS bus stops creating unsafe conditions for pedestrians and vehicular traffic. Surprisingly there is no lighting arrangement at most of the BRTS bus stops.

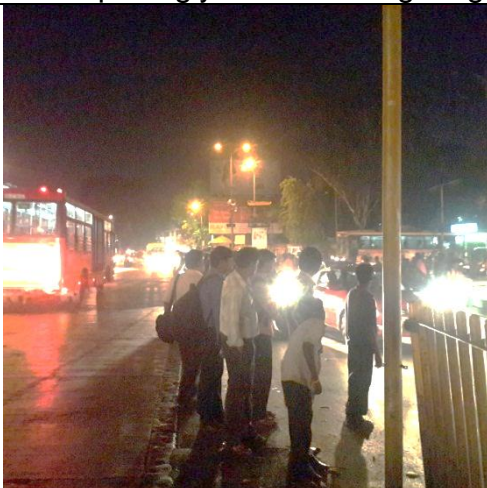
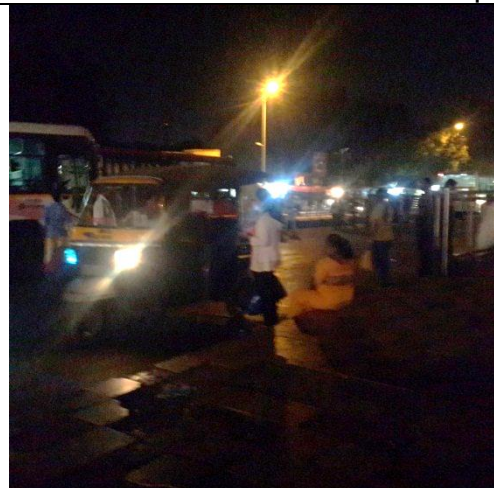
Chainage 5/825 m 18.500131, 73.858385: Pedestrians cross the road across heavy commercial traffic and buses due to absence of raised pedestrian crossings endangering pedestrian safety. Senior citizens, students are the most affected by lack of pedestrian facilities.

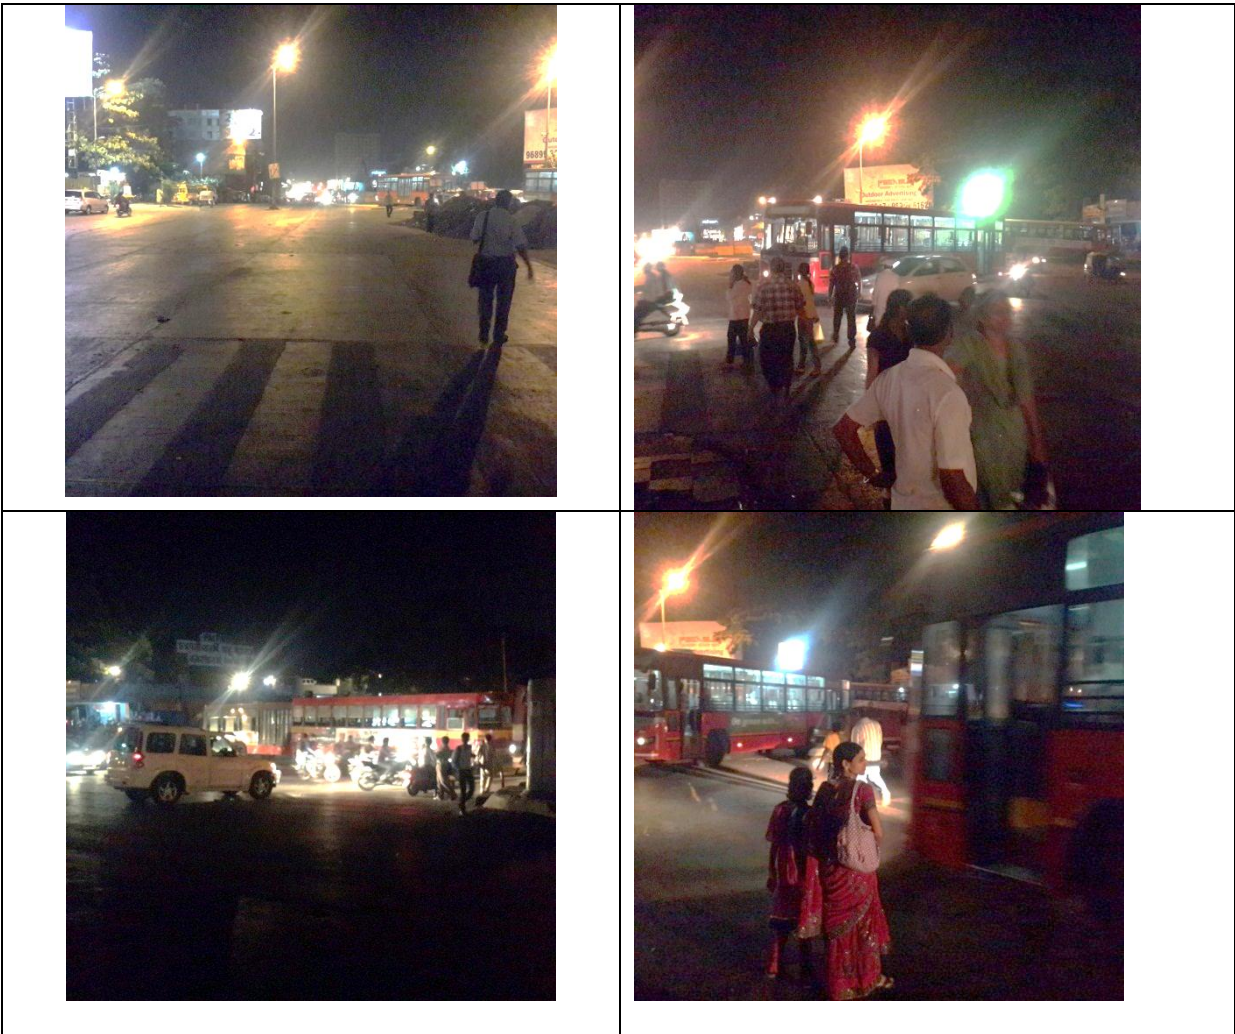
Swargate junction Chainage 5/800 m 18.498676, 73.858310– Removal of channellization island, wide road width, poor illumination and lack of traffic signal creates a chaotic situation in front of Swargate Bus depot entrance putting two wheelers and pedestrians at high risk of physical injury. The lighting arrangement at the edge of the ROW is inadequate to illuminate the ROW and BRTS corridor. Street light poles are installed at the extreme edge of the ROW. BRTS is partially functional and buses going towards Katraj from the bus stop move at high speed when entering the intersection.

21. Traffic calming measures like speed breakers, humps, speed tables / raised crossings, channelizes / traffic islands shall be constructed immediately to slow down and channelize the haphazardly moving traffic at the Swargate junction. New Jersey type barriers (precast RCC movable barriers) as recommended by IRC may be used for the traffic segregation. The movement of S.T. buses exiting the terminus towards Satara side shall be signalized to avoid confusion and inconvenience to other road users. The parked auto rickshaws and hawkers on either side of this road stretch shall be immediately evicted and temporarily dedicated rickshaw stands shall be demarcated at Swargate junction during ongoing construction **(Phase I)**.

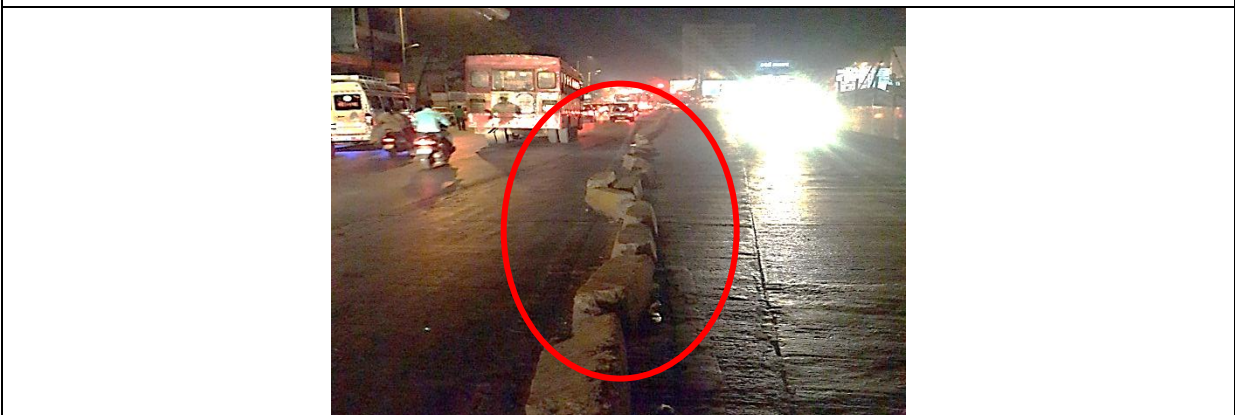
Chainage 5/750 RHS side 18.497496, 73.858310: Haphazardly placed concrete blocks and lack of any road markings pose a hazard due to lack of adequate illumination.

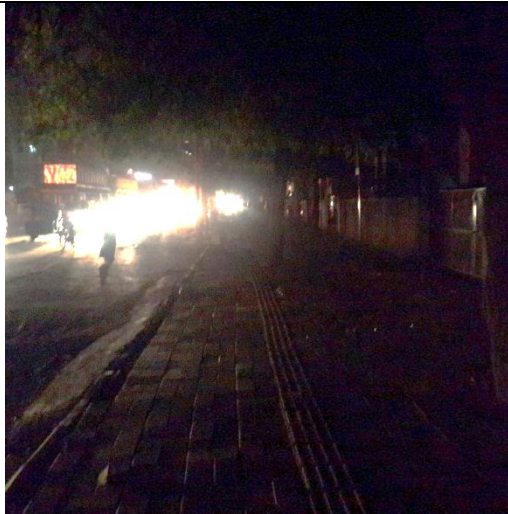
Chainage 5/725 RHS side 18.497089, 73.858310: Lack of any illumination on footpath outside Swargate State Transport Terminus. There is complete darkness in 60 -70 m portion of footpath.

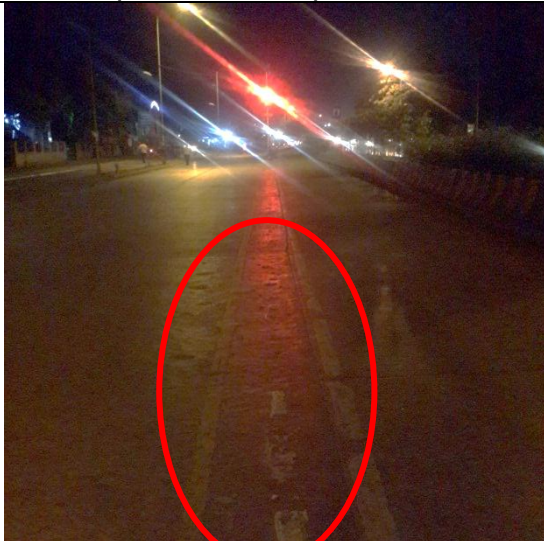
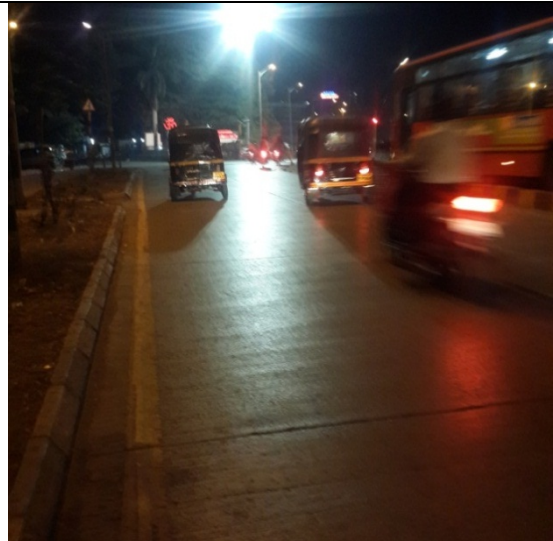
Chainage 3/600 m and 3/700 m RHS side 18.481847, 73.857473: The thermoplastic painting at road edge, between lanes in the BRTS corridor as well as main carriageway is faint/faded and lacks adequate reflectivity.

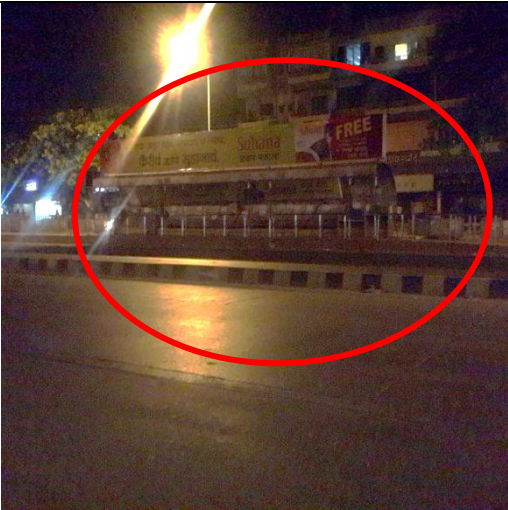
Chainage 4/800 m and 3/700 m LHS 18.478082, 73.857344: BRTS bus stop near Market Yard Junction and near Padmavati junction lacks any lighting arrangement. The BRTS corridor also lacks any street lighting arrangement thereby putting pedestrians to risk when crossing the road during night time.

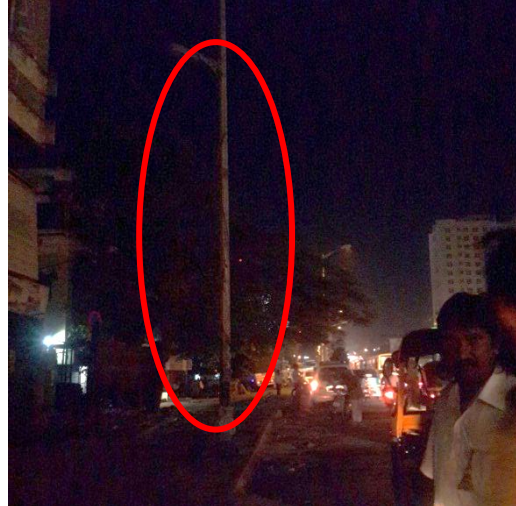
Chainage 5/500 RHS side 18.496377, 73.858213: Completely dark footpath and cycle track near Laxminarayan junction. The defunct street light poles and high mast poles should be made functional.

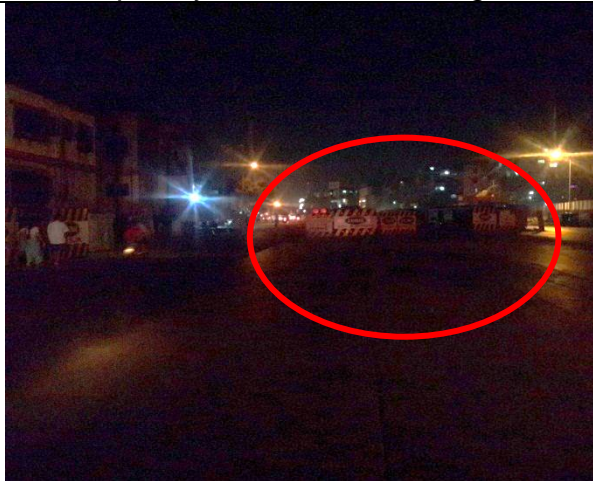
Chainage 3/100 RHS side 18.472608, 73.856325: Sudden reduction in the carriageway by barricading without adequate warning needs to be rectified by erecting advanced warning signs at the start of construction area of Dhankawadi flyover. The reflectors/ reflective material on the barricades are not enough to clearly mark the restricted carriageway width. Traffic blinkers and directional indicators need to be installed to guide vehicles.

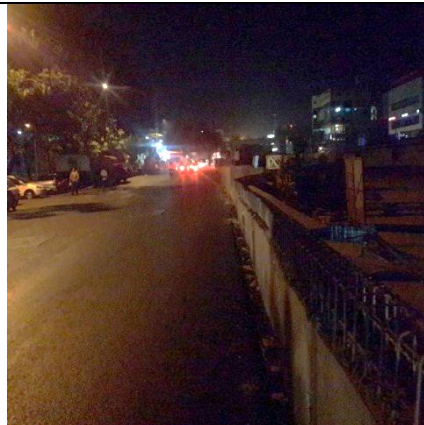
Chainage 3/000 RHS side 18.471570, 73.856947: Exposed reinforcement of ramp wall at the approach to flyover along the main carriageway near Shankar Maharaj

Math has to be barricaded. There is no clear demarcation by paint etc to direct the vehicles away from the ongoing construction work. There are no reflectors, reflective tape etc to clearly mark the ongoing construction work. This creates hazardous conditions for two wheelers as the reinforcement steel is at a low level and may cause serious injury to the two wheeler rider.

23. Restoration of barricading with immediate effect shall be enforced along the length of the retaining wall under construction with exposed reinforcement steel at Dhankawadi flyover construction site. It is recommended to provide segregated pedestrian passage by erecting MS barricading in every ongoing construction zone **(Phase I)**.

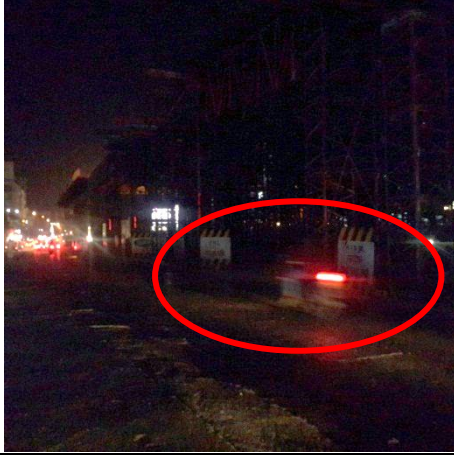
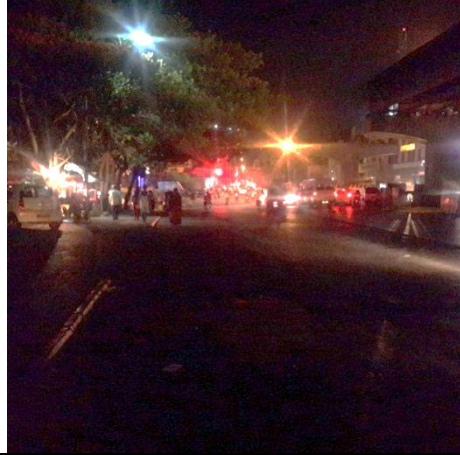
Chainage 2/700 RHS side 18.464080, 73.857805: Addition of reflectors, blinkers along the construction barricading to offset the poor lighting arrangements is urgently necessary.

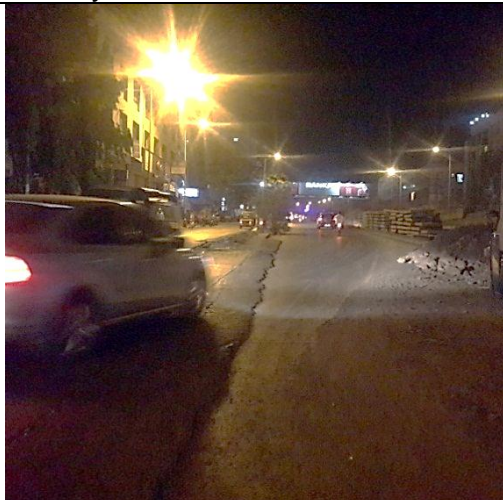
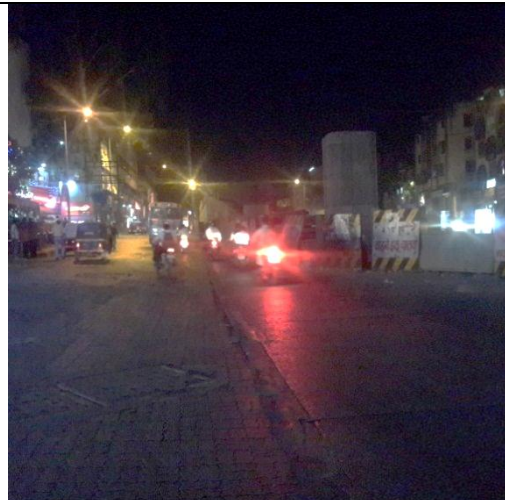
Chainage 2/450 RHS side: Poor condition of the carriageway, restricted width of the road due to barricading and inadequate traffic safety measures at ongoing construction site during night time creates difficult scenario for driver and other road users. At the location near petrol pump at Dhankawadi, there is lack of separate pedestrian space and constricted carriageway and bus stop at this location creates a very unsafe travel condition for pedestrians.

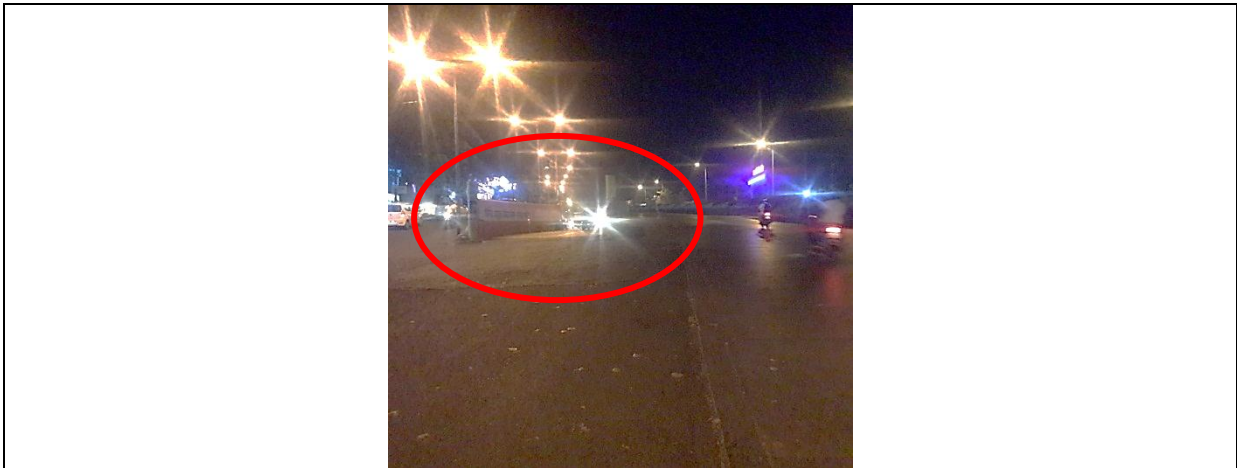
Chainage 1/350 RHS side 18.460213, 73.858213: Entrance to the vehicular subway to Bharati Vidyapeeth lacks any advance direction signage. The RCC walls at the entrance of the subway lack any hazard marker, retro reflective board etc.

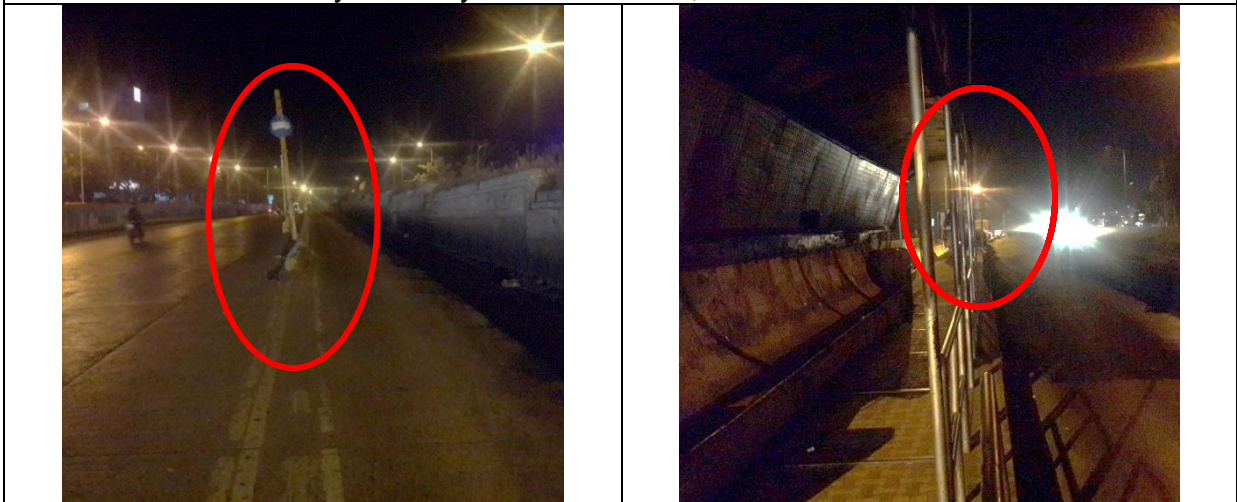
Chainage 1/300 RHS side: The BRTS corridor starting abruptly in front of Bharati Vidyapeeth gate without advanced warning or hazard marker on the kerb / chevron marking etc. Bust stop in front of Bharati Vidyapeeth is without any light arrangement.

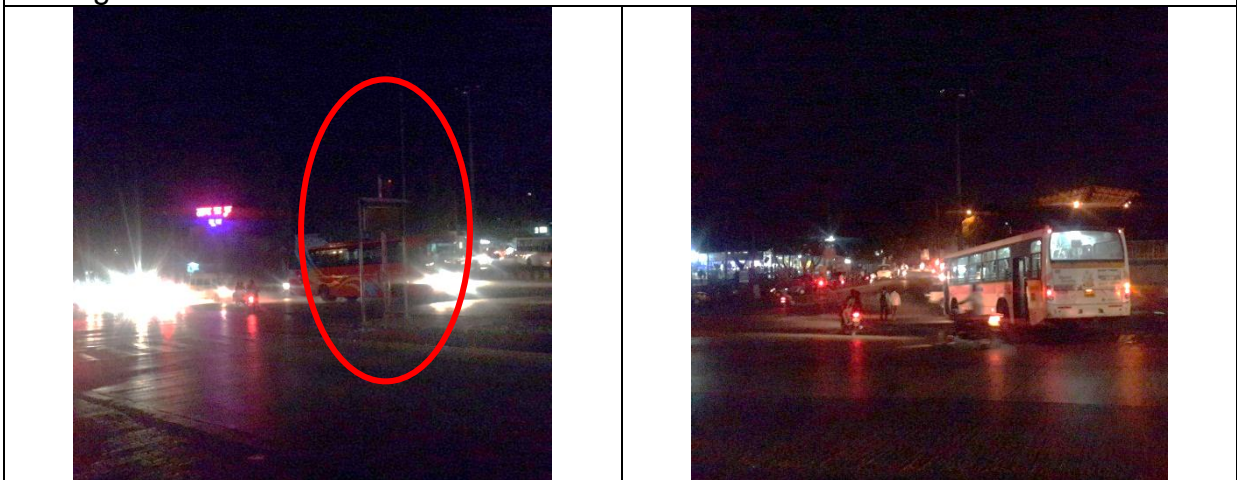
Chainage 0/850 18.460213, 73.858213: Poor illumination at Katraj Dairy junction.- Defunct high mast poles, uncontrolled junction without any channellization, traffic signal etc pose high risk to all users. There is completely chaotic situation at this

junction coupled with very poor condition of the road pavement.

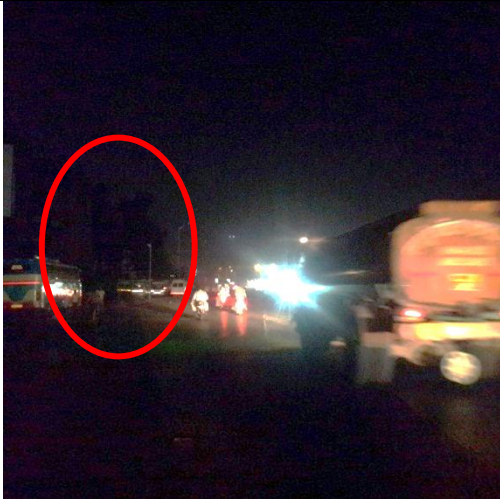
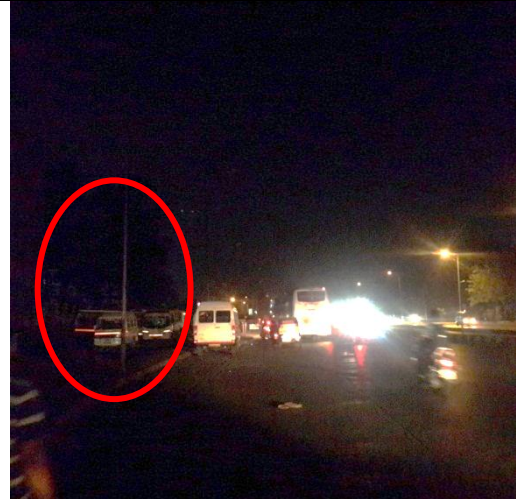
Chainage 0/950 m LHS side 18.455873, 73.858422: Completely dark section between Katraj and Bharati Vidyapeeth without any functional street lighting, high mast poles creating a very unsafe corridor for vehicles and especially for pedestrians.

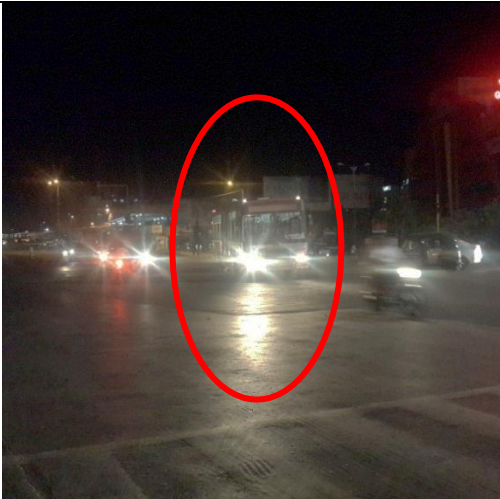
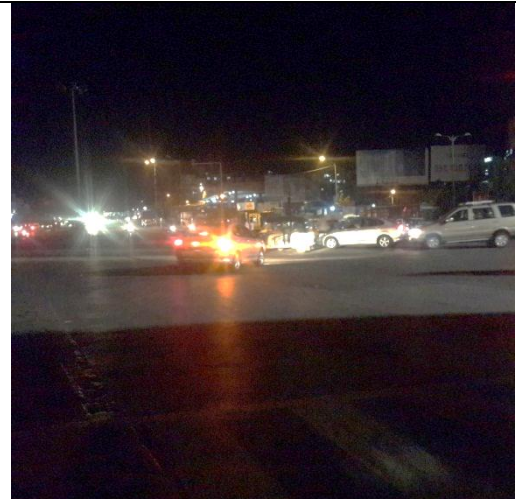
Chainage 0/110 m 18.448688, 73.857993: Completely uncontrolled Katraj junction at intersection of Pune Satara Road and Dehu Road Bypass. Traffic control measures need to be urgently implemented during the night time.

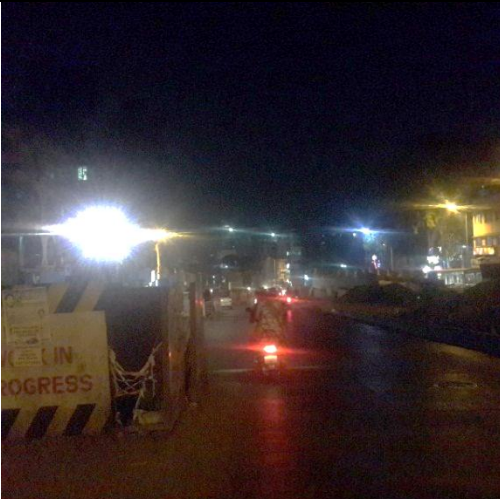
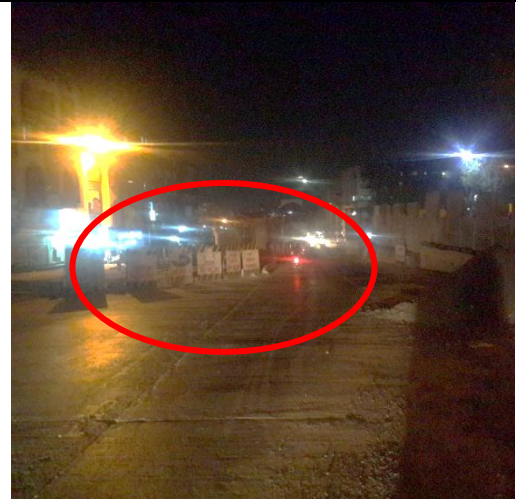
Chainage 2/500 m LHS side 18.463730, 73.857778: Lack of adequate night time safety measures like reflectors, blinkers, advanced direction boards and hazard markers at the ingoing construction near Dhankawadi Bus route junction

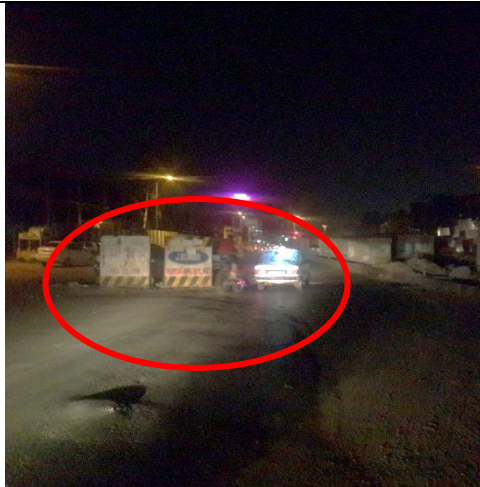
Chainage 2/900 m LHS side 18.470894, 73.857006: Sudden reduction in carriageway width due to ongoing construction near Shankar Maharaj Math without any advanced warning sign. Vehicles moving at high speeds on the down slope unexpectedly encounter the barricading with inadequately marked steel barricades with poor illumination.

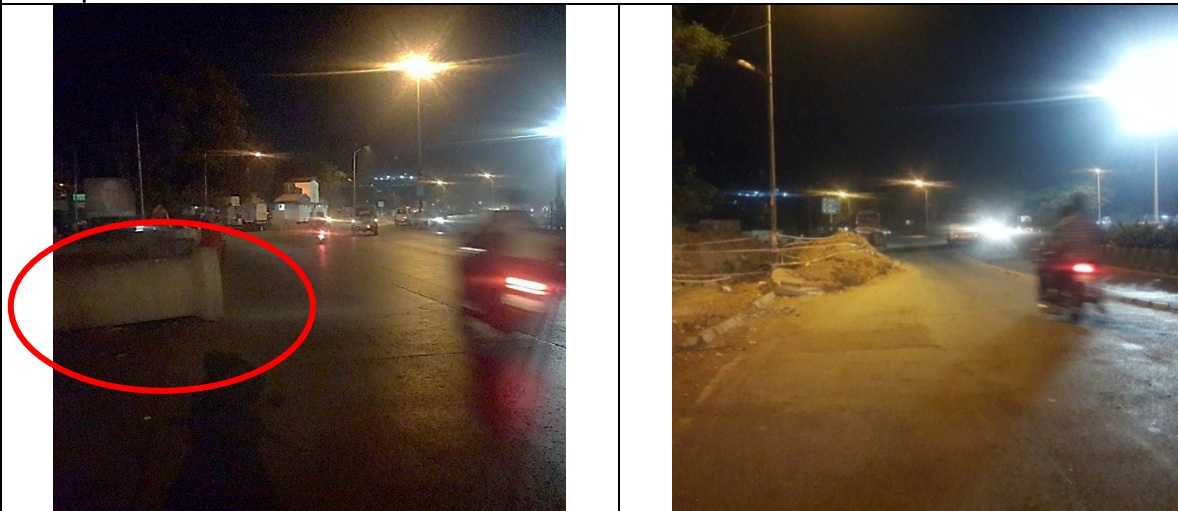
Chainage 3/200 LHS side 18.475127, 73.855997: RCC pipes and excavated stuff lying on the carriageway without advanced warning signage or proper safety measures will tend to create accident spot.

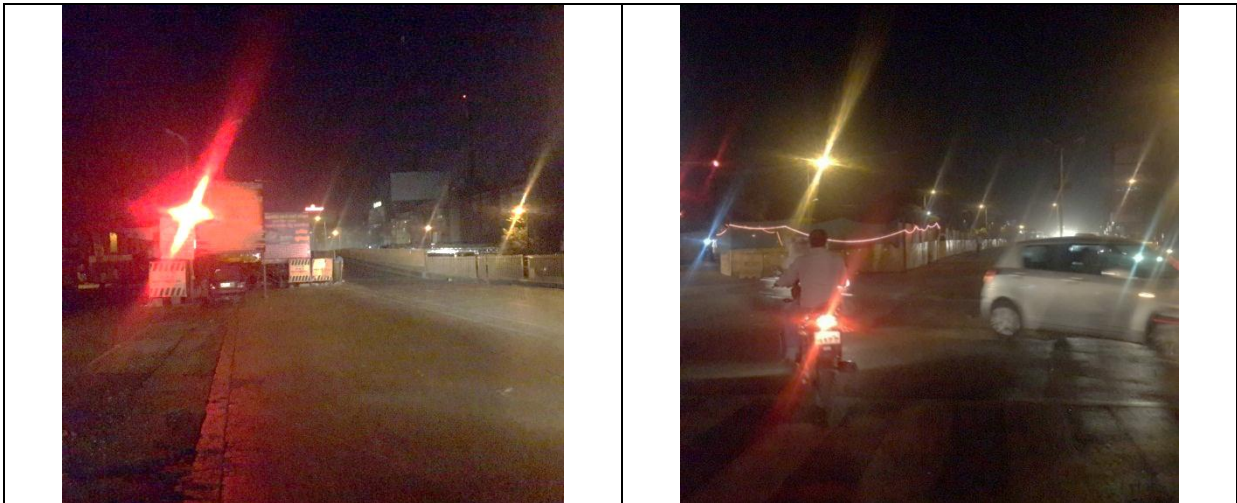
Chainage 5/600 LHS side 18.497228, 73.857842: The barricading for ongoing construction of flyover near Swargate junction lacks any advanced warning sign of construction zone. The construction safety measures during night time are meagre and need improvement with adequate number of reflectors, traffic blinkers reflective tapes proper barricading etc.
